THE VILLAGES AND LAWSON HILLS MPDs
2012-2013 PRE-CONSTRUCTION
STORMWATER MONITORING IN ROCK CREEK
TO ESTABLISH THE BASELINE PHOSPHORUS LOAD

BLACK DIAMOND, WA

NOVEMBER 2013

(REVISED JANUARY 2014)

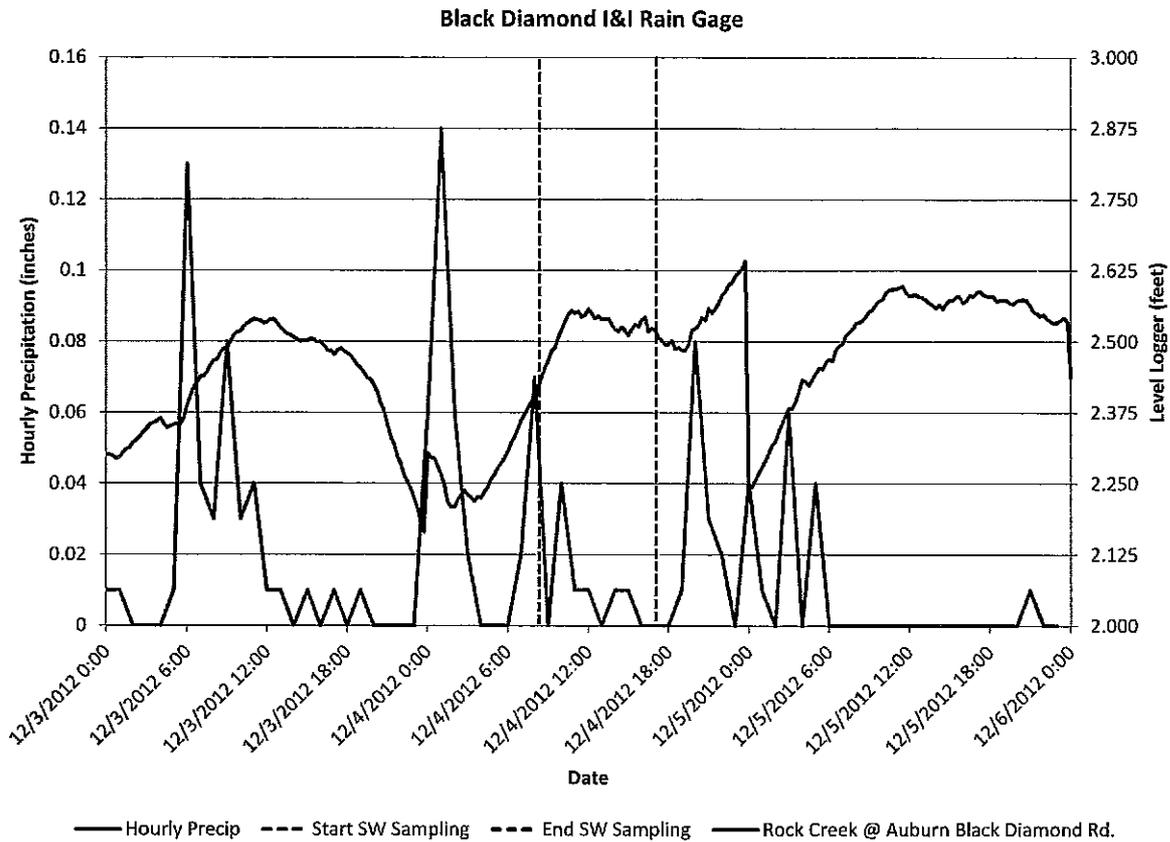
Figure 12. Precipitation at the Black Diamond I&I Rain Gage for the December 4, 2012 Sampling Event Compared to Rock Creek Water Level Recorded at SE Auburn Black Diamond Road

The first stormwater samples were collected on December 4, 2012 beginning at 08:20 with the last storm event set of sample collection ending at 17:00. Figure 12 shows precipitation at the Black Diamond I&I rain gage (operated by King County) and water level recordings in Rock Creek at SE Auburn Black Diamond Road. Precipitation for December 4, 2012 (for the 24 hour period) totaled 0.47 inches.

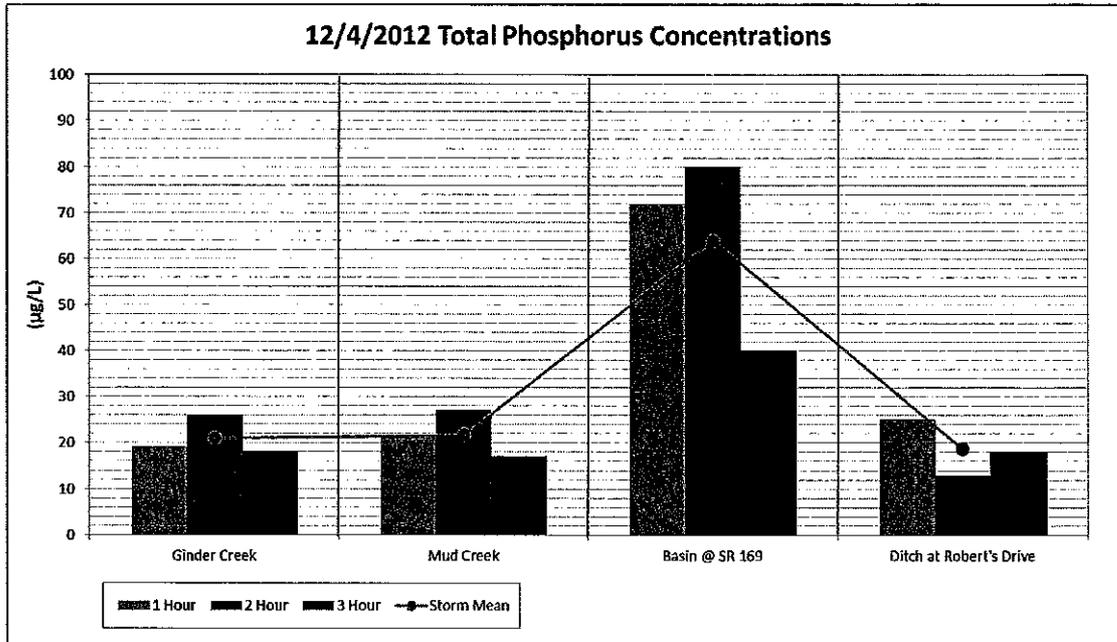
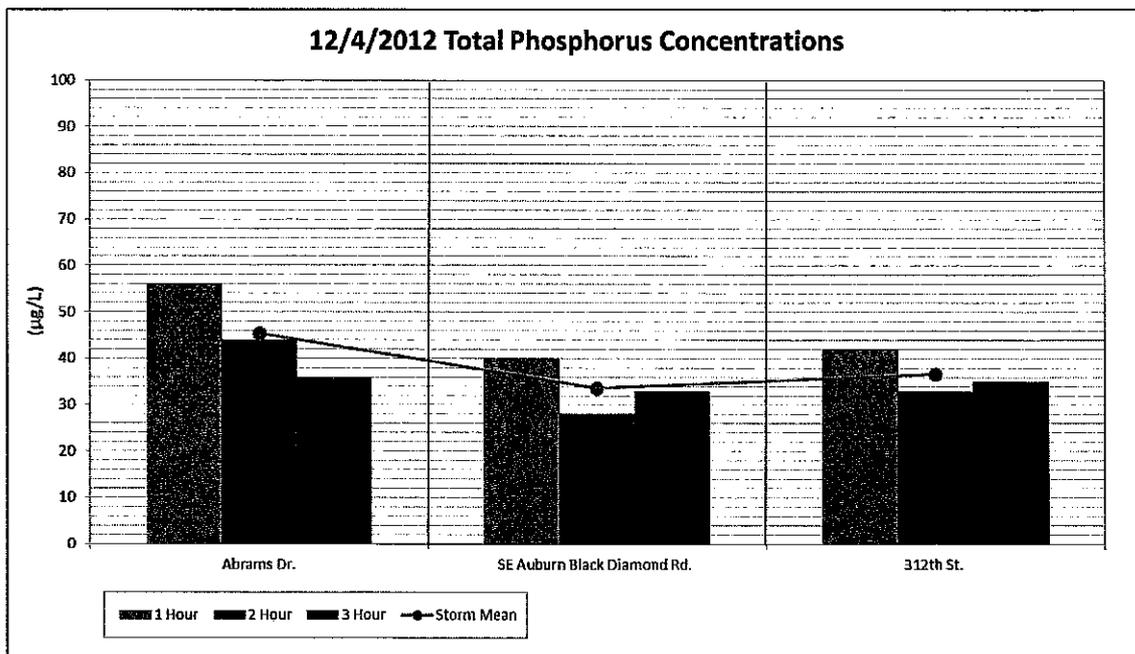
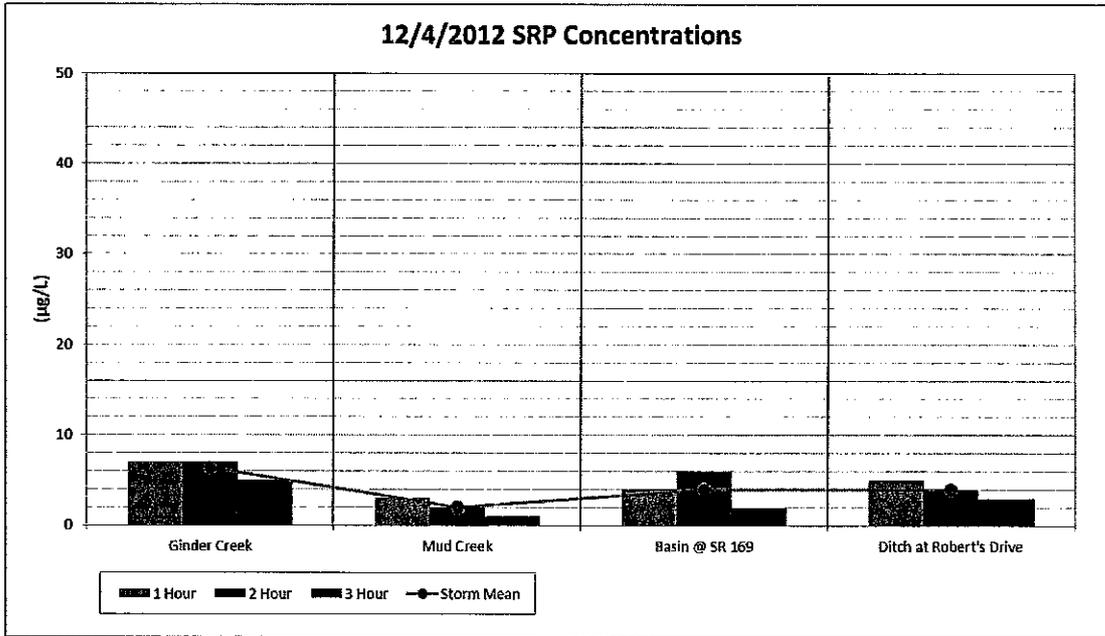
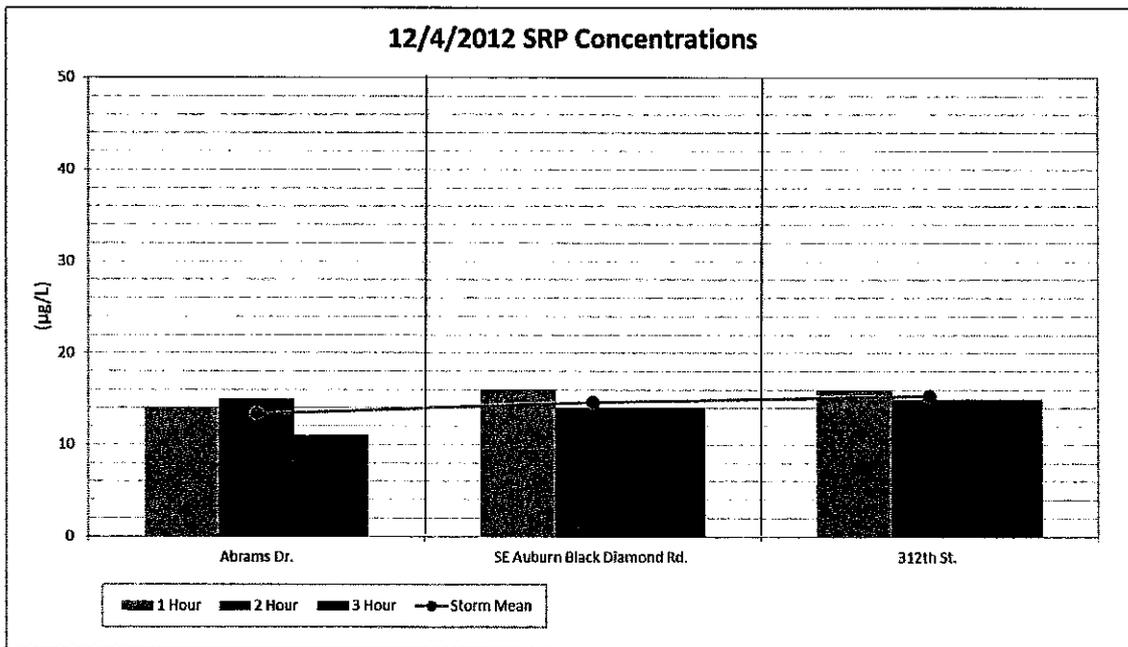
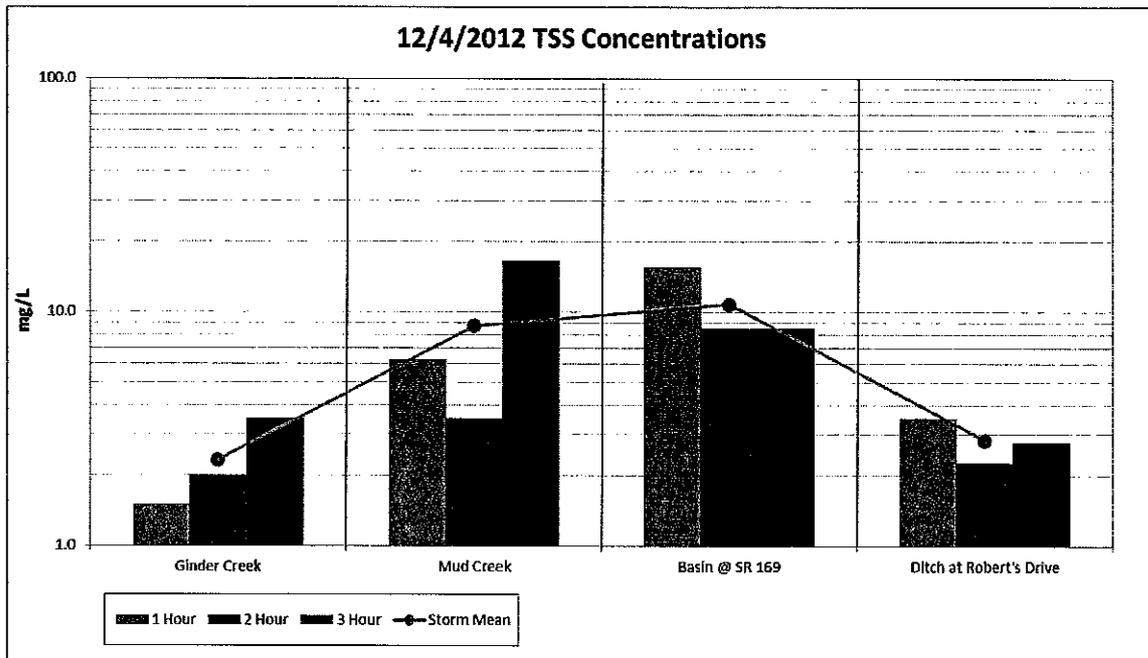
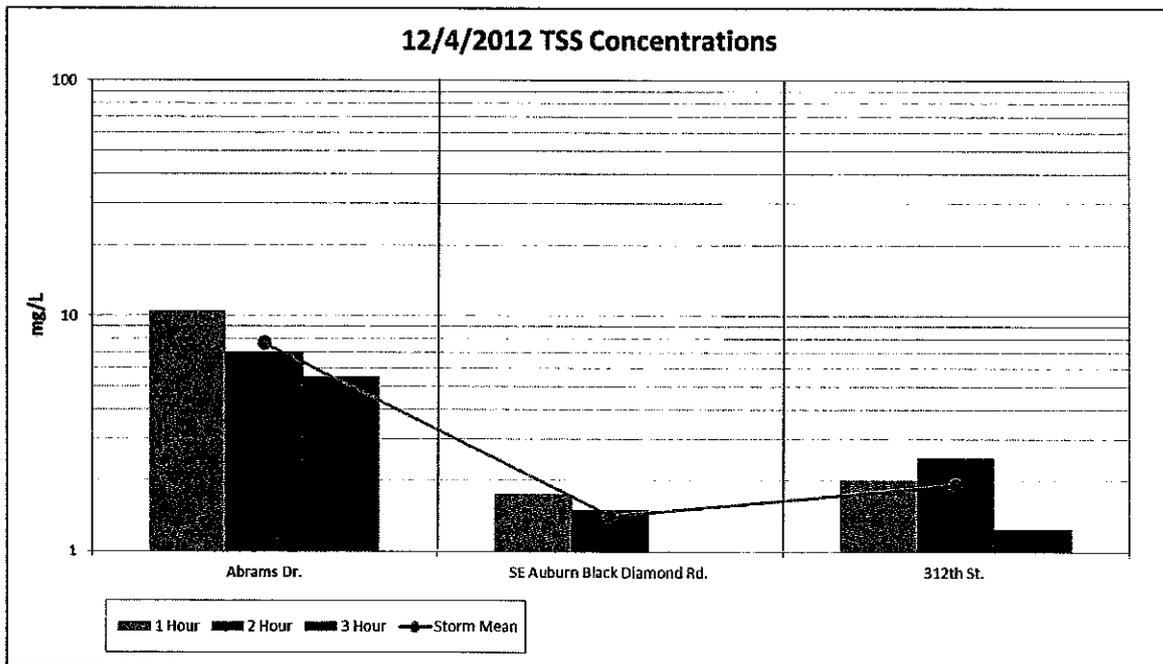
Figure 13. Total phosphorus concentrations in the Lake Sawyer drainage basin during the 12/4/2012 stormwater sampling event.

Figure 14. Total phosphorus concentrations in Rock Creek during the 12/4/2012 stormwater sampling event.

Figure 15. Soluble reactive phosphorus concentrations in the Lake Sawyer drainage during the 12/4/2012 stormwater sampling event.

Figure 16. Soluble reactive phosphorus concentrations in Rock Creek during the 12/4/2012 stormwater sampling event.

Figure 17. Total suspended solids concentrations in the Lake Sawyer drainage during the 12/4/2012 stormwater sampling event

Figure 18. Total suspended solids concentrations in the Rock Creek drainage during the 12/4/2012 stormwater sampling event

Water quality data from laboratory analysis from the December 4, 2012 storm event are presented in Appendix 1, Table A1. A comparison of TP, SRP, and TSS results among sites are shown in Figures 13-18.

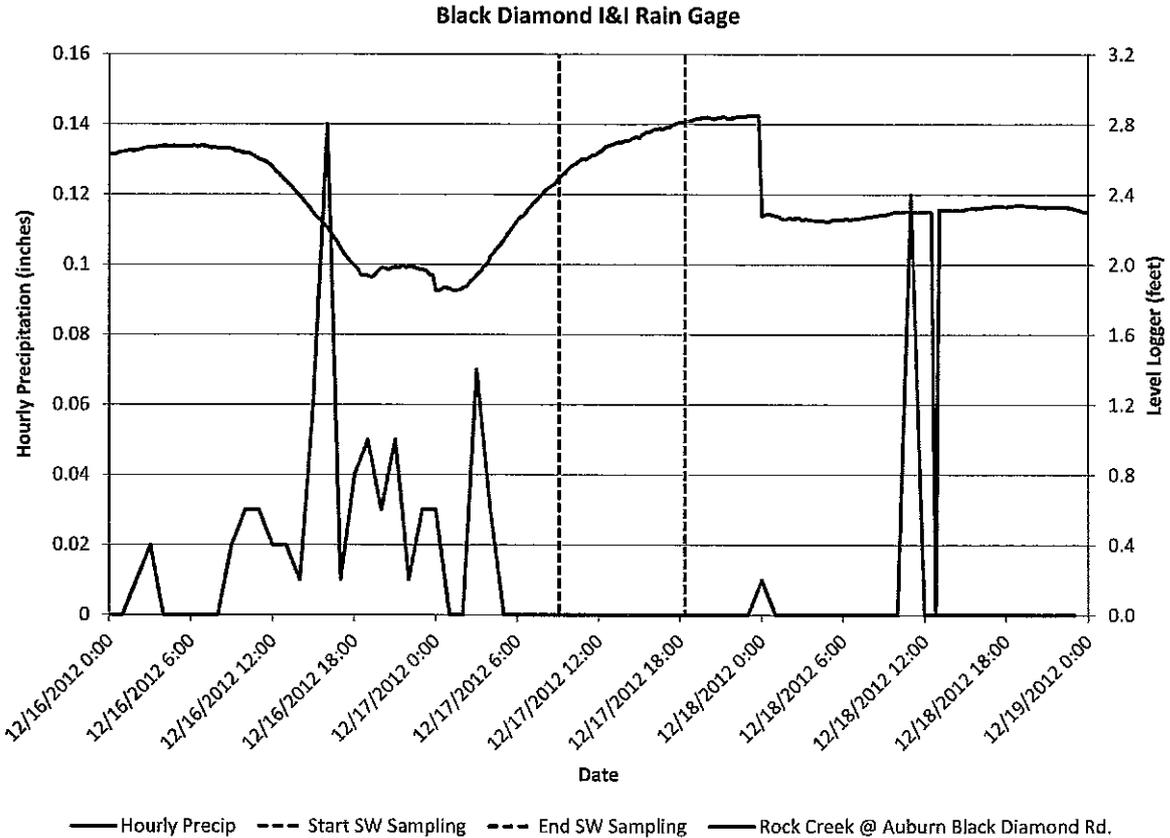
Figure 19. Precipitation at the Black Diamond I&I Rain Gage for the December 17, 2012 Sampling Event Compared to Rock Creek Water Level Recorded at SE Auburn Black Diamond Road

A second set of stormwater samples were collected on December 17, 2012 from 09:15 through 18:15. Figure 19 reports precipitation at the Black Diamond I&I rain gage (operated by King County) during the sampling event with corresponding water levels (level logger records) at the Rock Creek at SE Auburn Black Diamond Road. Precipitation for December 17, 2012 (for the 24 hour period) totaled 0.49 inches.

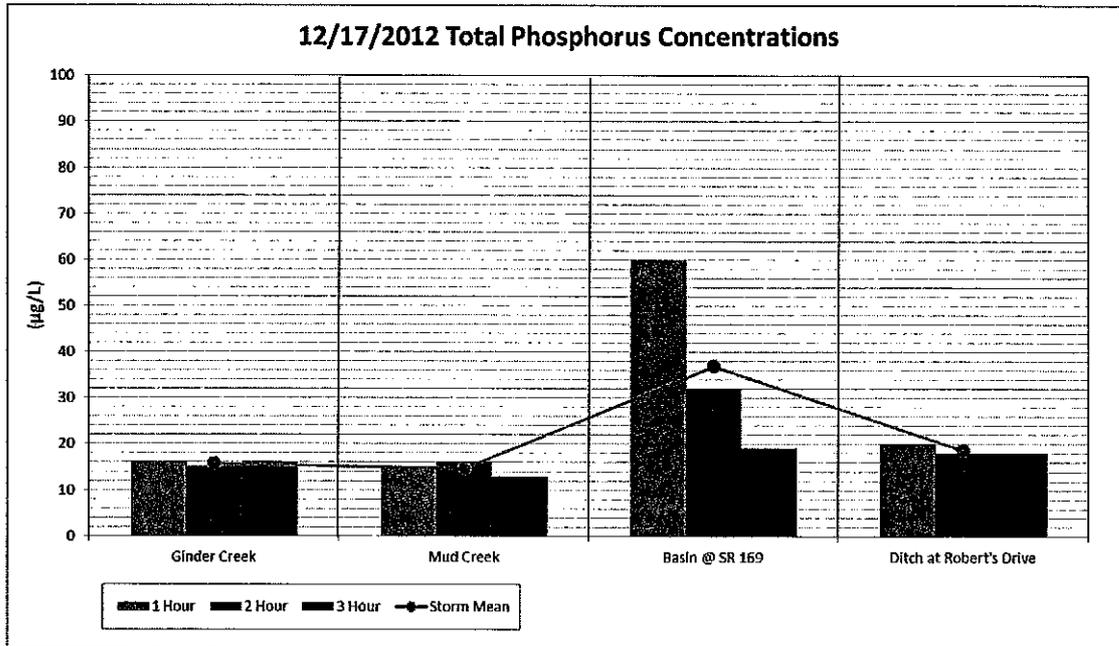
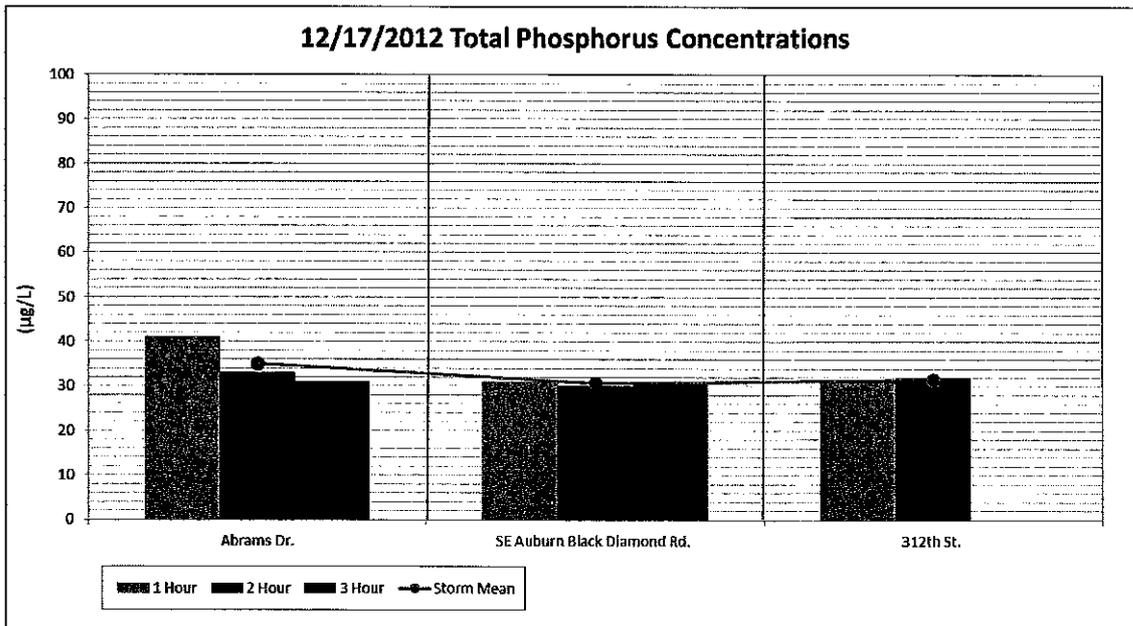
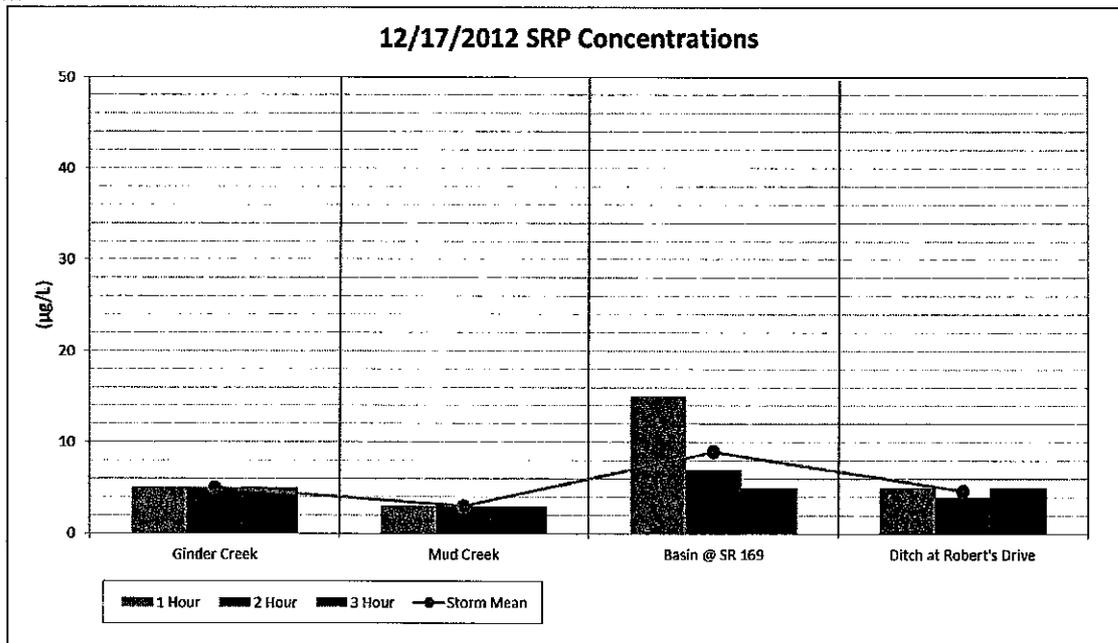
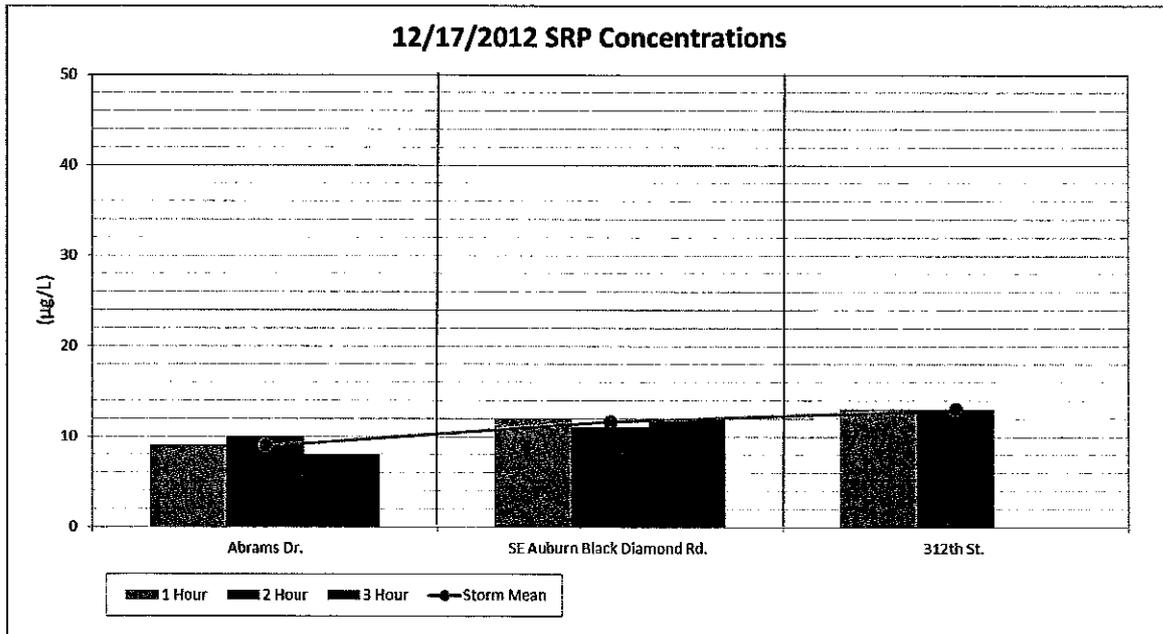
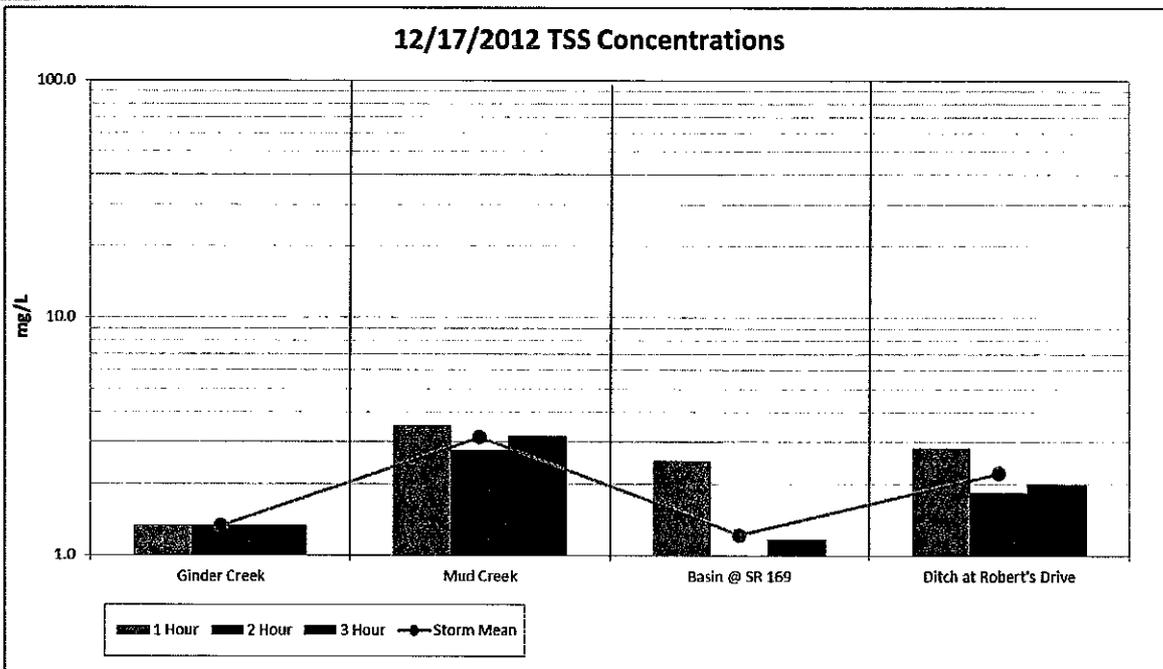
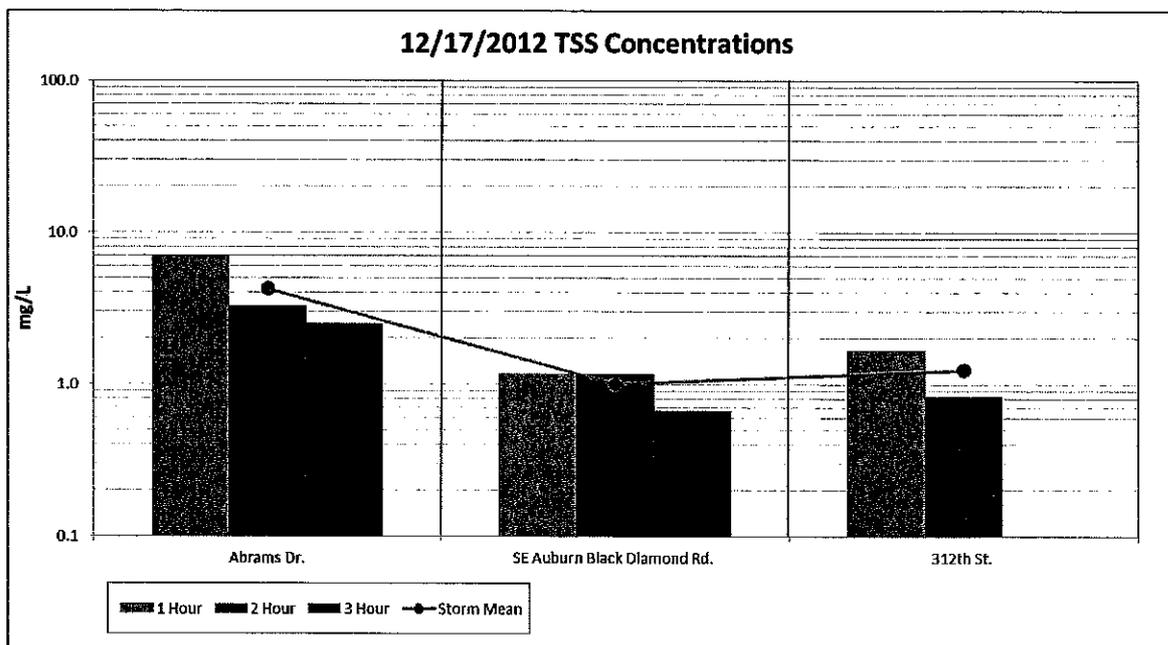
Figure 20. Total phosphorus concentrations in the Lake Sawyer Drainage Basin during the 12/17/2012 stormwater sampling event

Figure 21. Total phosphorus concentrations in the Rock Creek drainage during the 12/17/2012 stormwater sampling event

Figure 22. Soluble reactive phosphorus concentrations in the Lake Sawyer drainage during the 12/17/2012 stormwater sampling event

Figure 23. Soluble reactive phosphorus concentrations for the 12/17/2012 stormwater sampling event

Figure 24. Total suspended solids concentrations for the Lake Sawyer drainage during the 12/17/2012 stormwater sampling event

Figure 25. Total suspended solids concentrations for the Lake Sawyer drainage during the 12/17/2012 stormwater sampling event

Water quality data from laboratory analysis for the December 17, 2013 storm event are presented in Appendix 1, Table A2 and field water quality measurements are reported in Table A3. A comparison of TP, SRP, and TSS results among sites are found below in Figures 20-25.

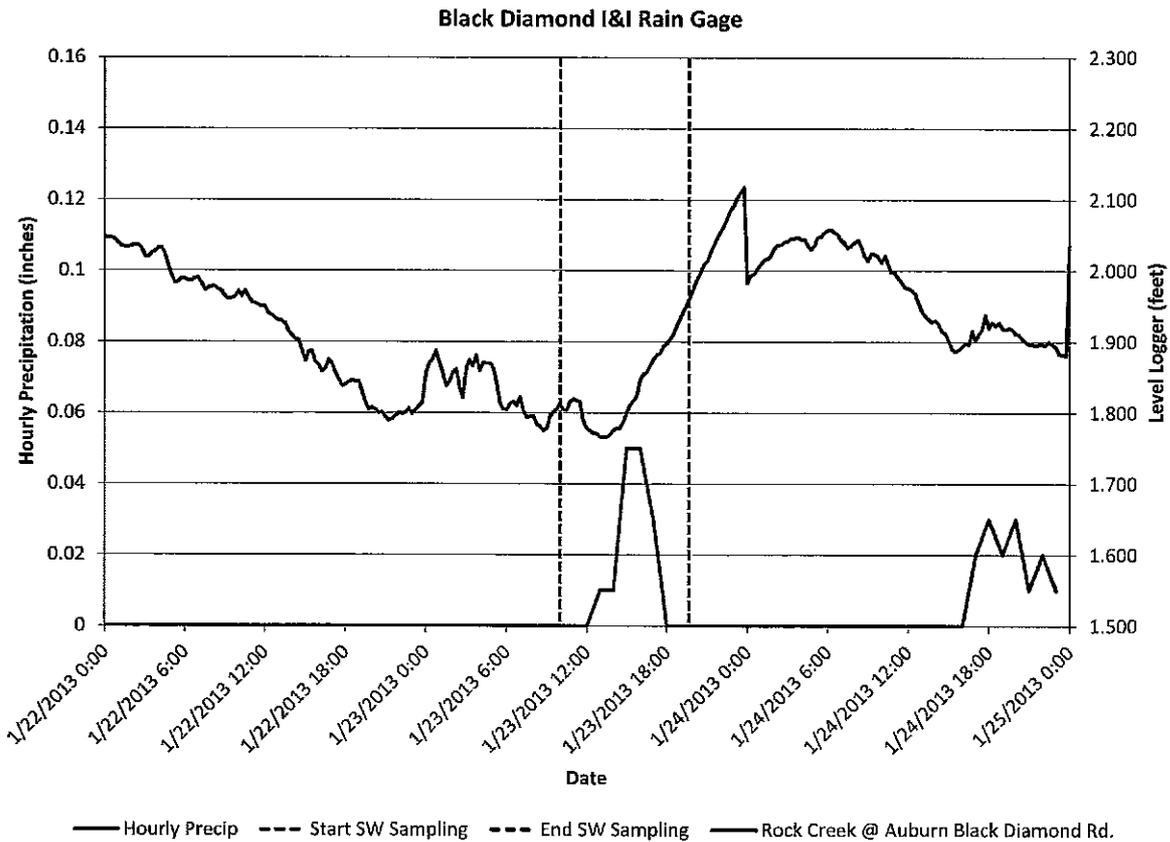
Figure 26. Precipitation at the Black Diamond I&I Rain Gage for the January 23, 2013 Sampling Event Compared to Rock Creek Water Level Recorded at SE Auburn Black Diamond Road.

Stormwater samples were collected from 10:10 to 19:45 on January 23, 2013. Figure 26 shows precipitation at the Black Diamond I&I rain gage (operated by King County) during the sampling event compared to water level recorded in Rock Creek at SE Auburn Black Diamond Road. Precipitation for January 23, 2013 (for the 24 hour period) totaled 0.15 inches.

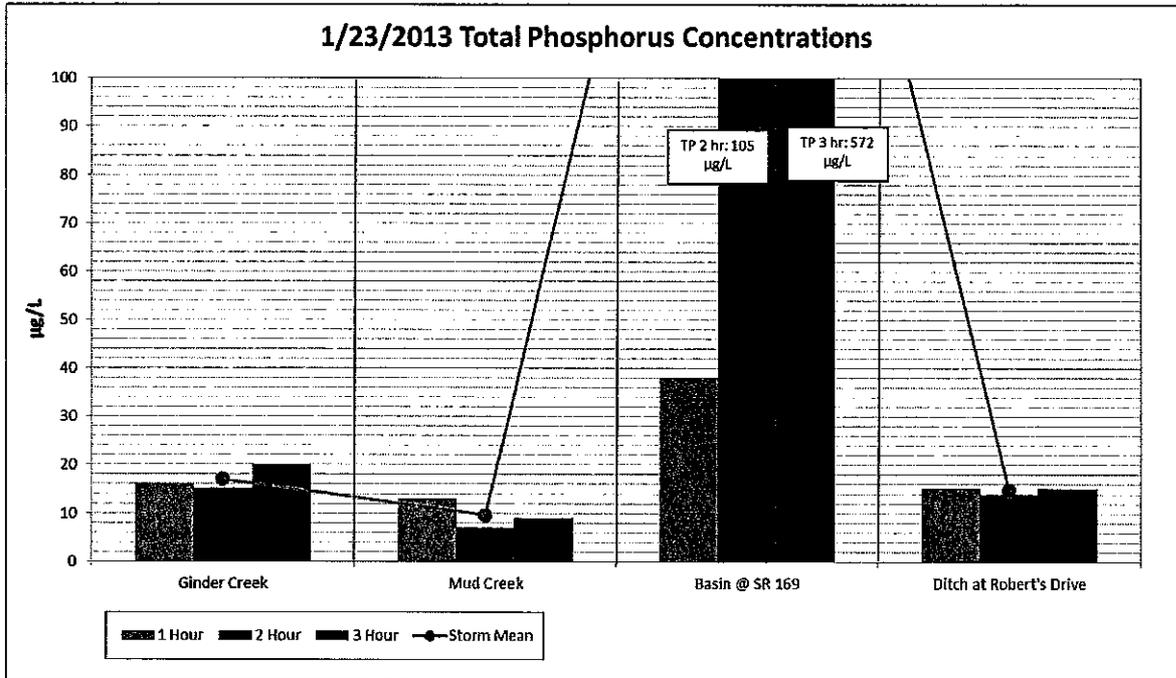
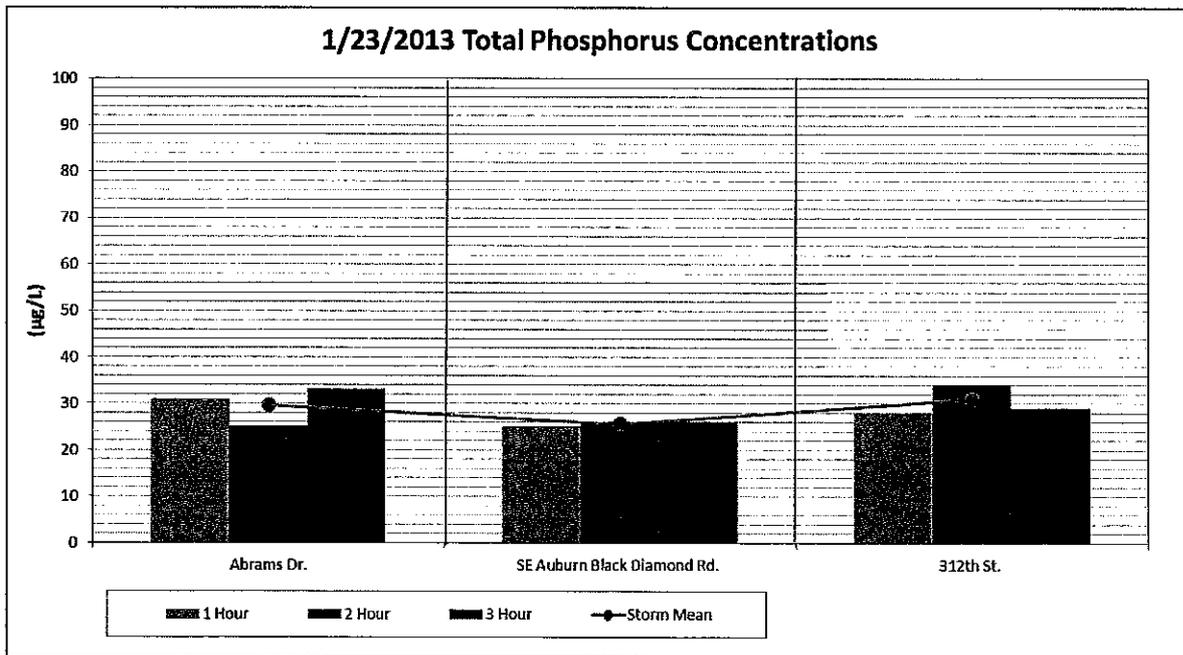
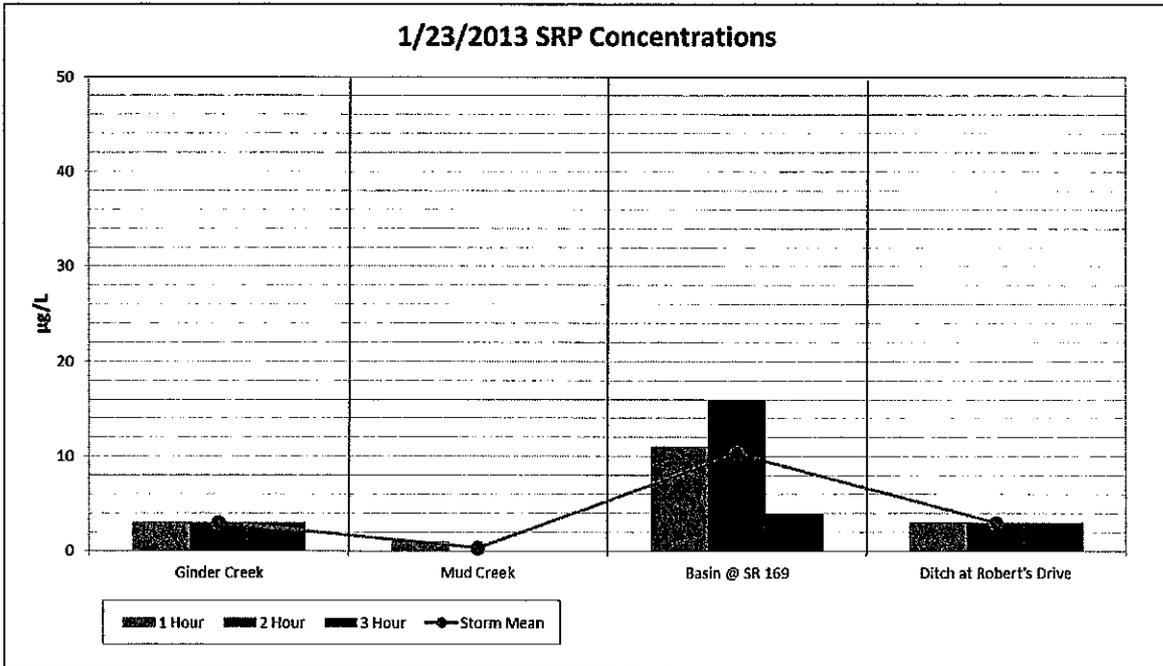
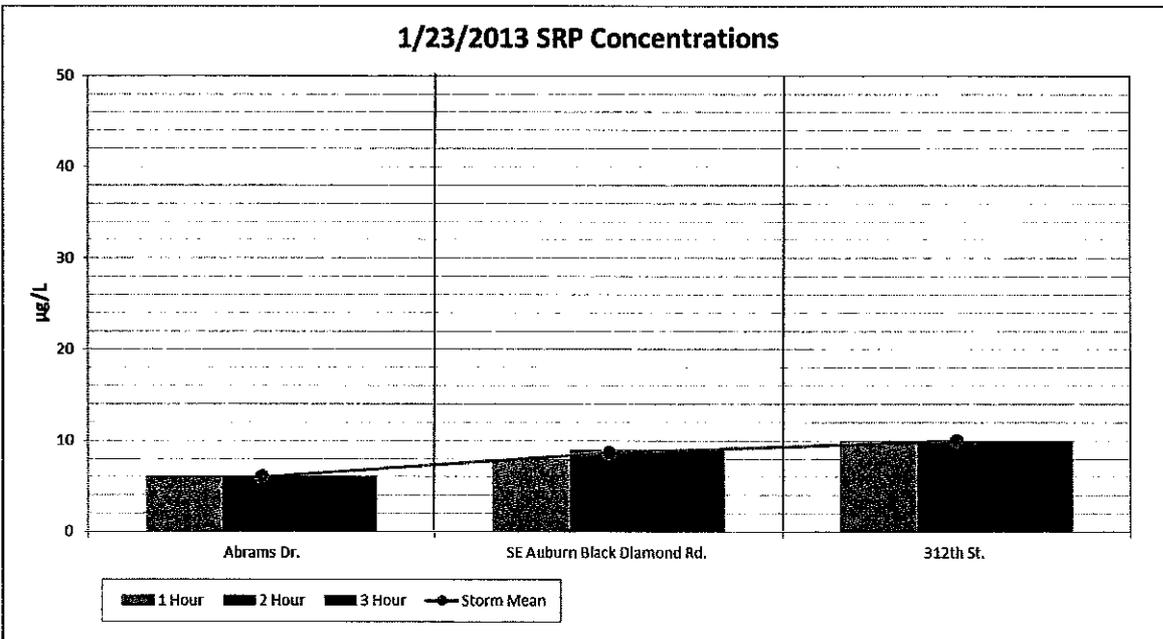
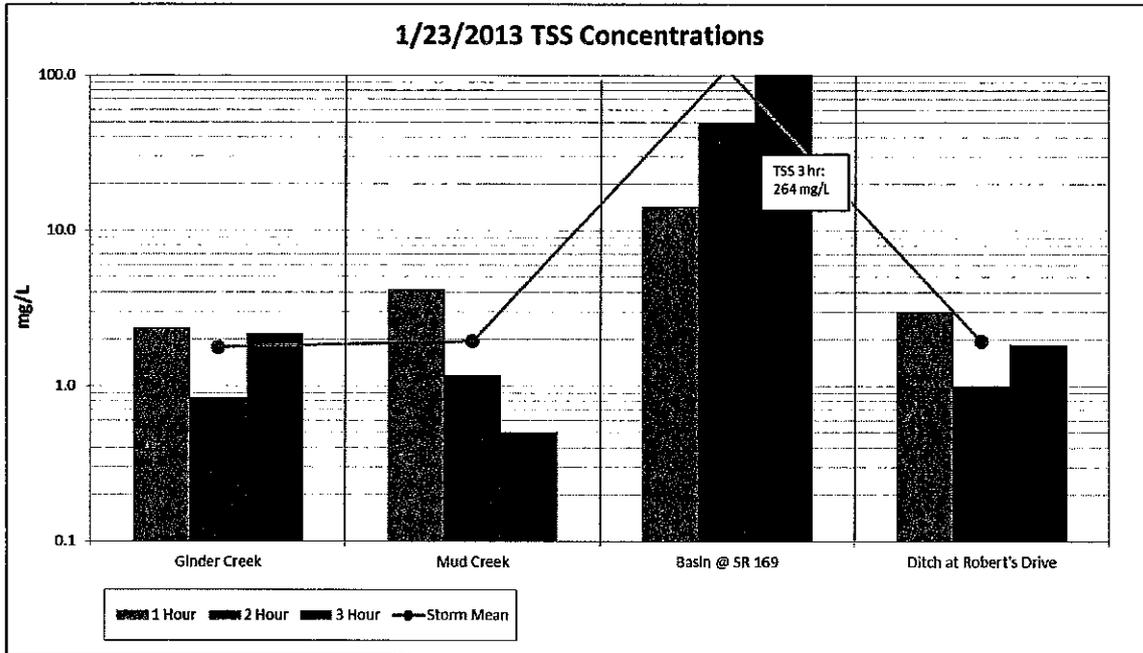
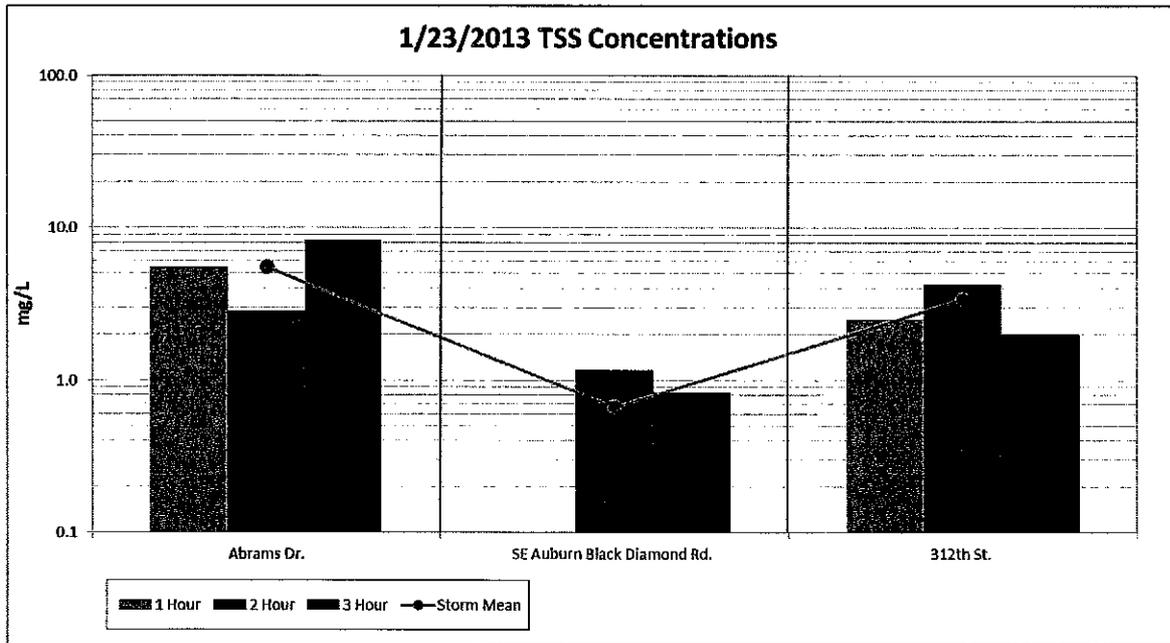
Figure 27. Total phosphorus concentrations for the Lake Sawyer drainage during the 1/23/2013 stormwater sampling event

Figure 28. Total phosphorus concentrations for the Rock Creek drainage during the 1/23/2013 stormwater sampling event

Figure 29. Soluble reactive phosphorus for the Lake Sawyer drainage during the 1/23/2013 stormwater sampling event

Figure 30. Soluble reactive phosphorus concentrations for the Rock Creek drainage during the 1/23/2013 stormwater sampling event

Figure 31. Total suspended solids concentrations for the Lake Sawyer drainage during the 1/23/2013 stormwater sampling event

Figure 32. Total suspended solids concentrations for the Rock Creek drainage during the 1/23/2013 stormwater sampling event

Water quality data from laboratory analysis from the January 23, 2013 storm event are presented in Appendix 1, Table A4 and field water quality measurements are reported in Table A5. A comparison of TP, SRP, and TSS results among sites are found below in Figures 27-32.

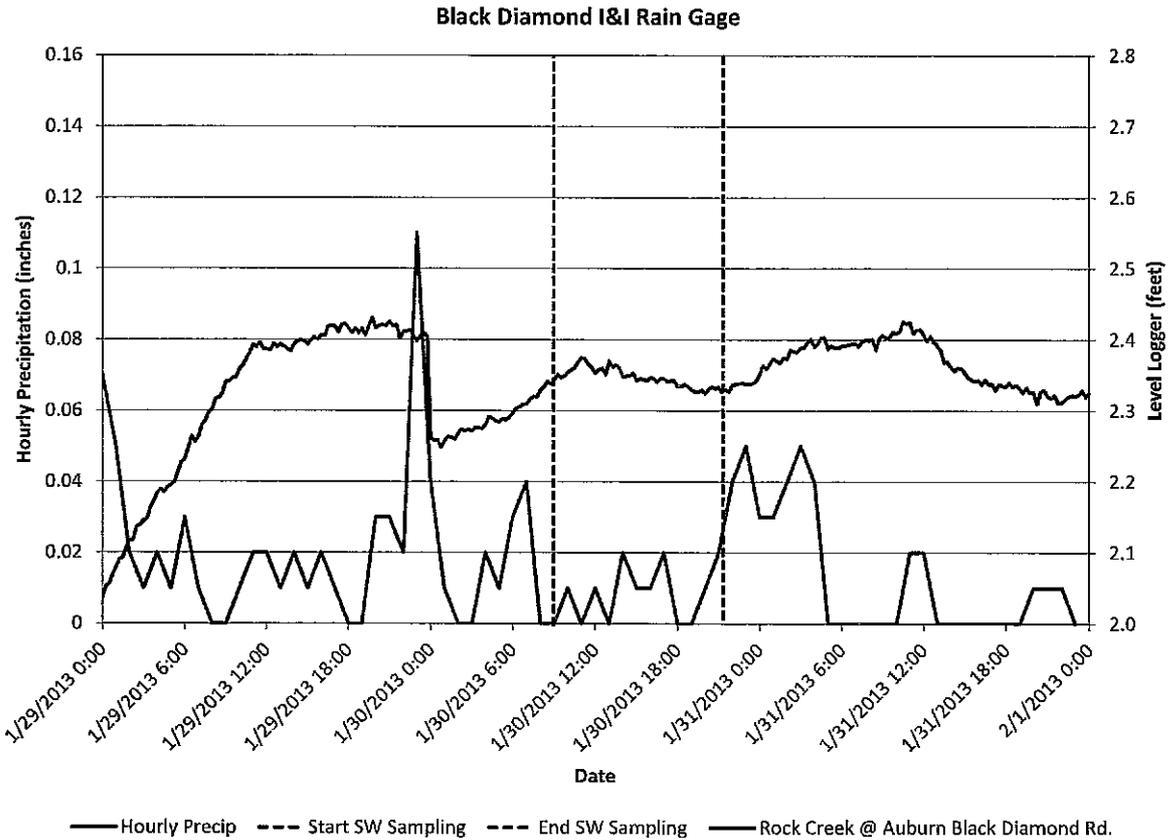
Figure 33. Precipitation at the Black Diamond I&I Rain Gage for the January 30, 2013 Sampling Event Compared to Rock Creek Water Level Recorded at SE Auburn Black Diamond Road.

Stormwater samples were collected from 9:00 to 21:30 on January 30, 2013. Figure 33 shows precipitation at the Black Diamond I&I rain gage (operated by King County) during the sampling event compared to water level recorded in Rock Creek at SE Auburn Black Diamond Road. Precipitation for January 30, 2013 (for the 24 hour period) totaled 0.42 inches.
