THE VILLAGES AND LAWSON HILLS MPDs
2012-2013 PRE-CONSTRUCTION
STORMWATER MONITORING IN ROCK CREEK
TO ESTABLISH THE BASELINE PHOSPHORUS LOAD

BLACK DIAMOND, WA

NOVEMBER 2013

(REVISED JANUARY 2014)

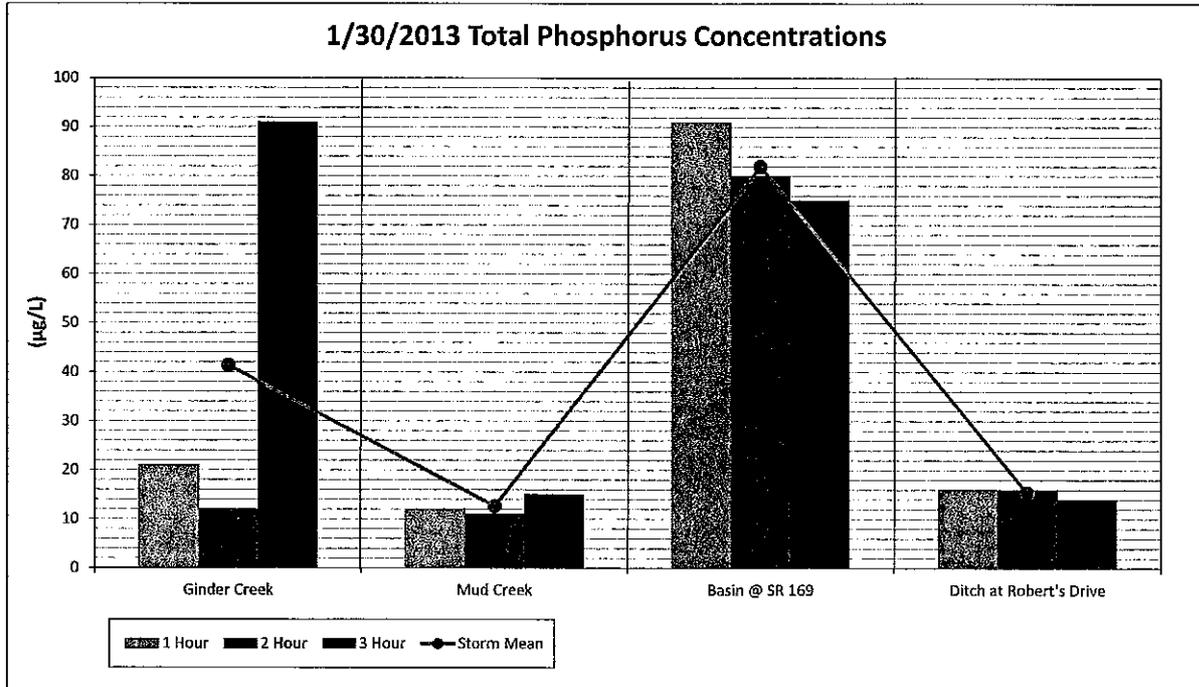
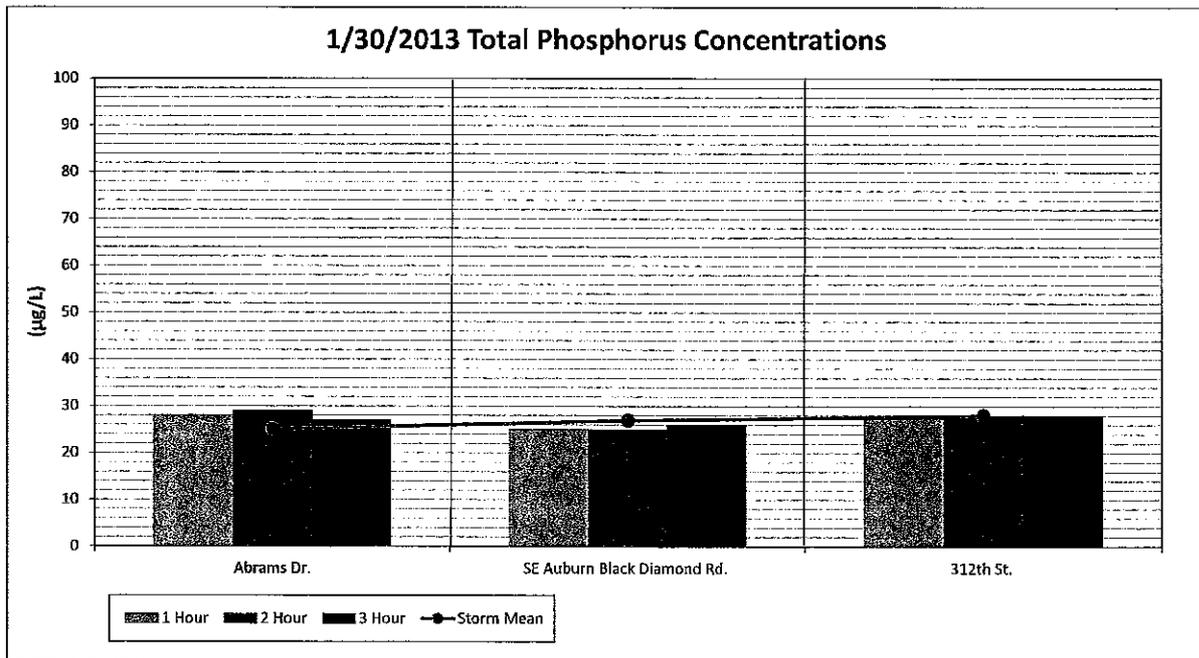
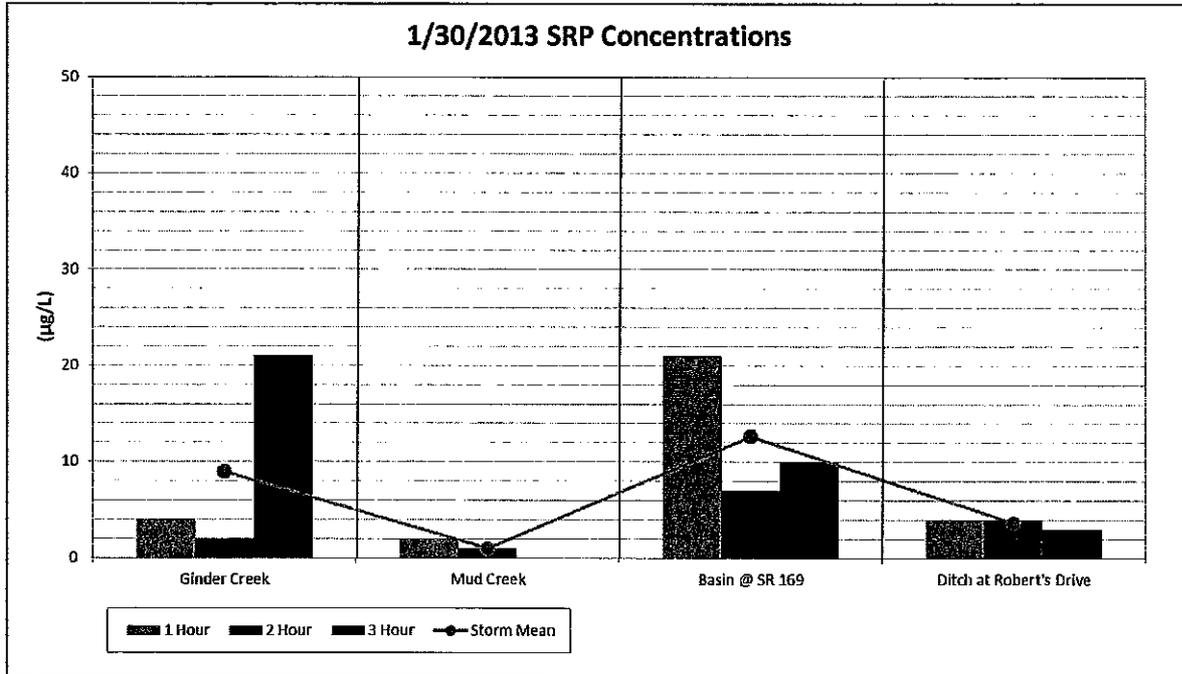
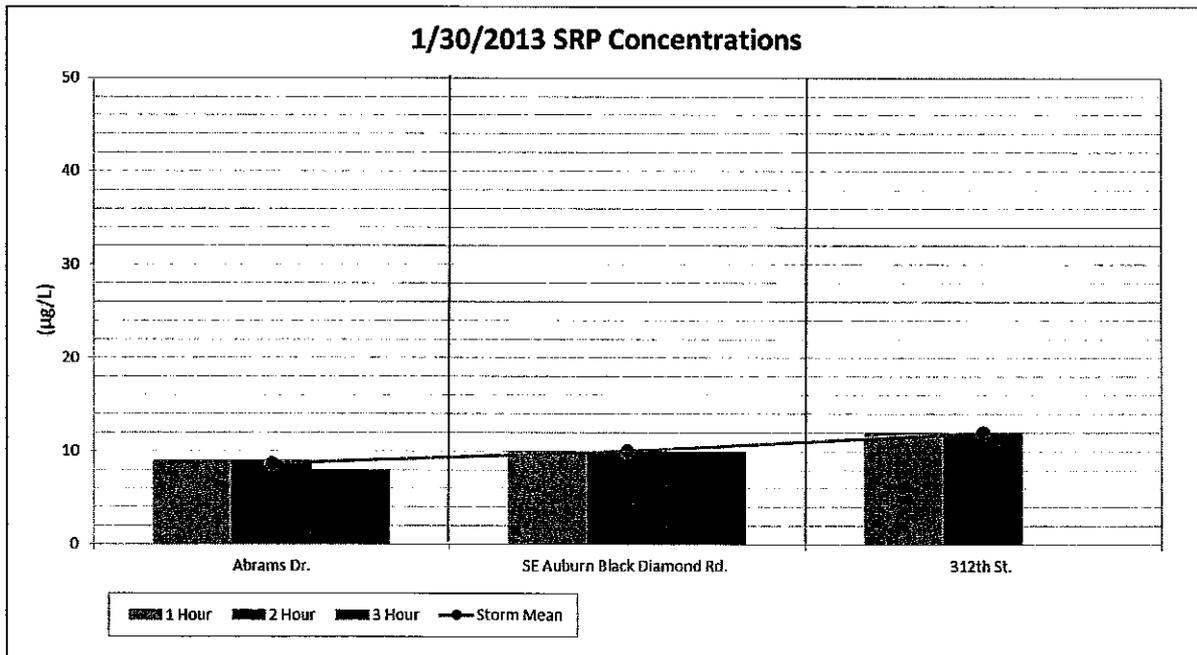
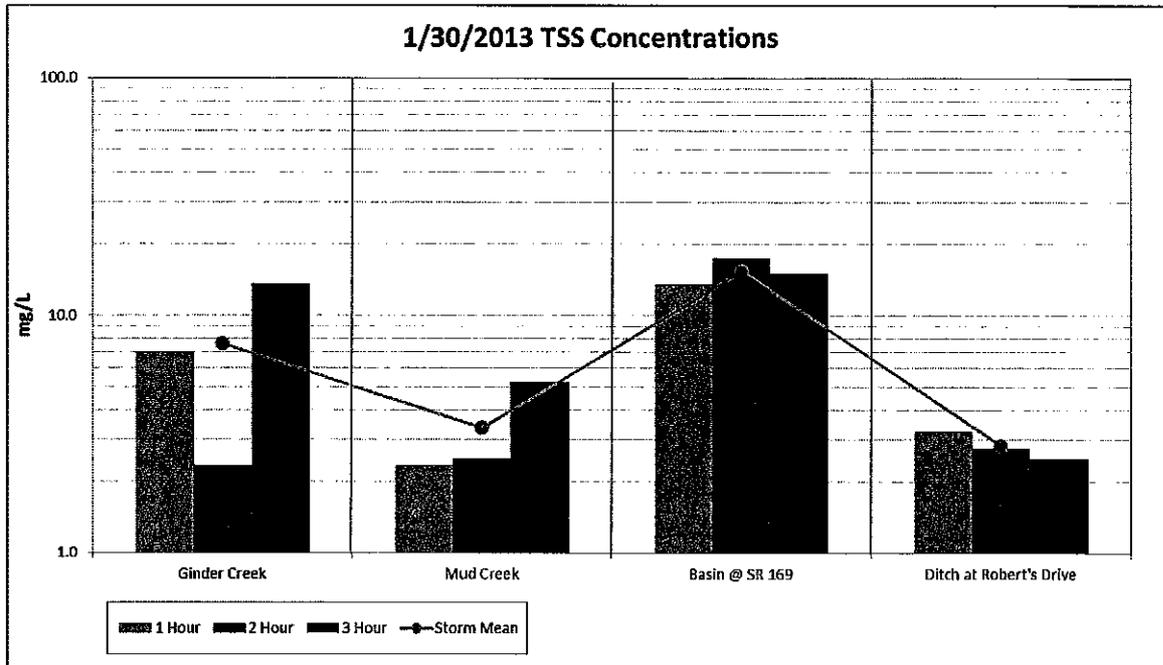
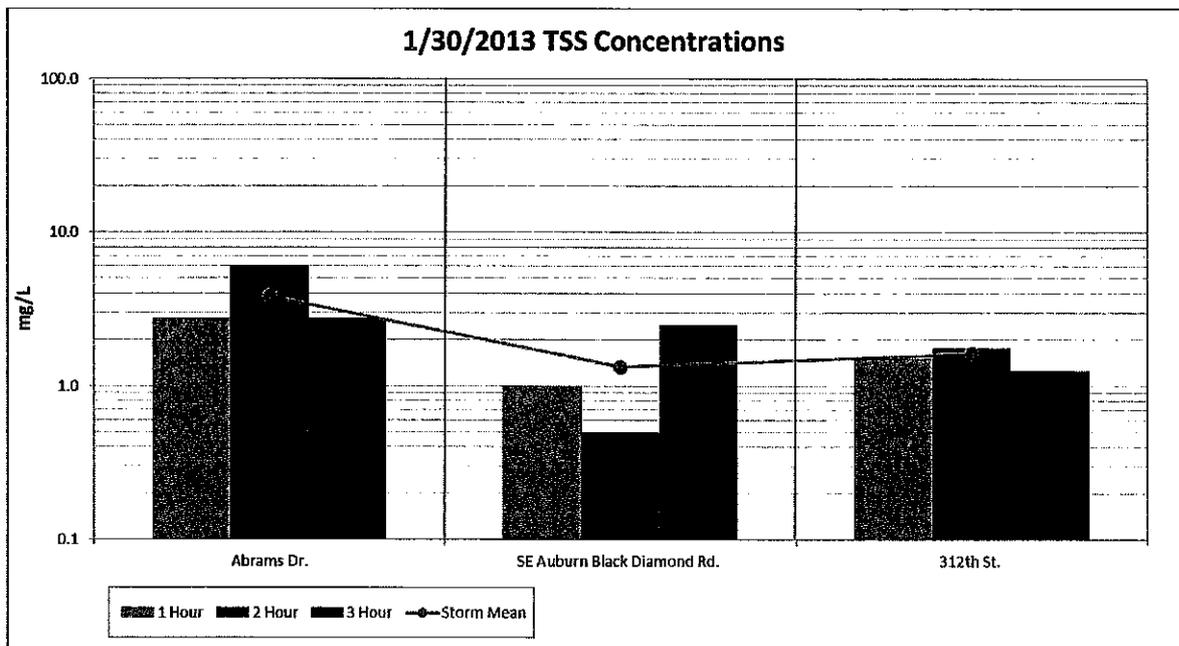
Figure 34. Total phosphorus concentrations in the Lake Sawyer drainage during the 1/30/2013 stormwater sampling event

Figure 35. Total phosphorus concentrations in the Rock Creek drainage during the 1/30/2013 stormwater sampling event

Figure 36. Soluble reactive phosphorus concentrations in the Lake Sawyer drainage during the 1/30/2013 stormwater sampling event

Figure 37. Soluble reactive phosphorus concentrations in the Rock Creek drainage during the 1/30/2013 stormwater sampling event

Figure 38. Total suspended solids concentrations in the Lake Sawyer drainage during the 1/30/2013 stormwater sampling event

Figure 39. Total suspended solids concentrations in the Rock Creek drainage during the 1/30/2013 stormwater sampling event

Water quality data from laboratory analysis for the January 30, 2013 storm event are presented in Appendix 1, Table A6 and field water quality measurements are reported in Table A7. A comparison of TP, SRP, and TSS results among sites are found below in Figures 34-39.

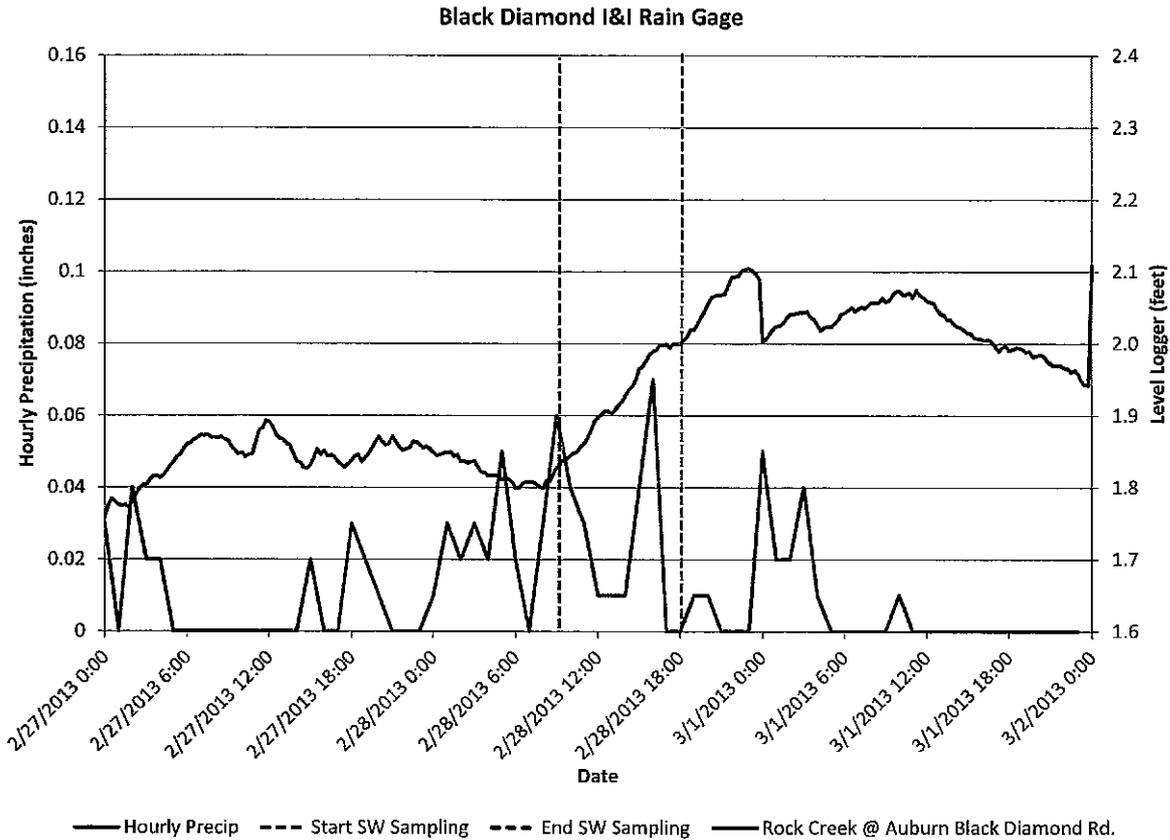
Figure 40. Precipitation at the Black Diamond I&I Rain Gage for the February 28, 2013 Sampling Event Compared to Rock Creek Water Level Recorded at SE Auburn Black Diamond Road.

Stormwater samples were collected from 9:00 to 17:15 on February 28, 2013. Figure 40 shows precipitation at the Black Diamond I&I rain gage (operated by King County) during the sampling event compared to water level recorded in Rock Creek at SE Auburn Black Diamond Road. Precipitation for February 28, 2013 (for the 24 hour period) totaled 0.47 inches.

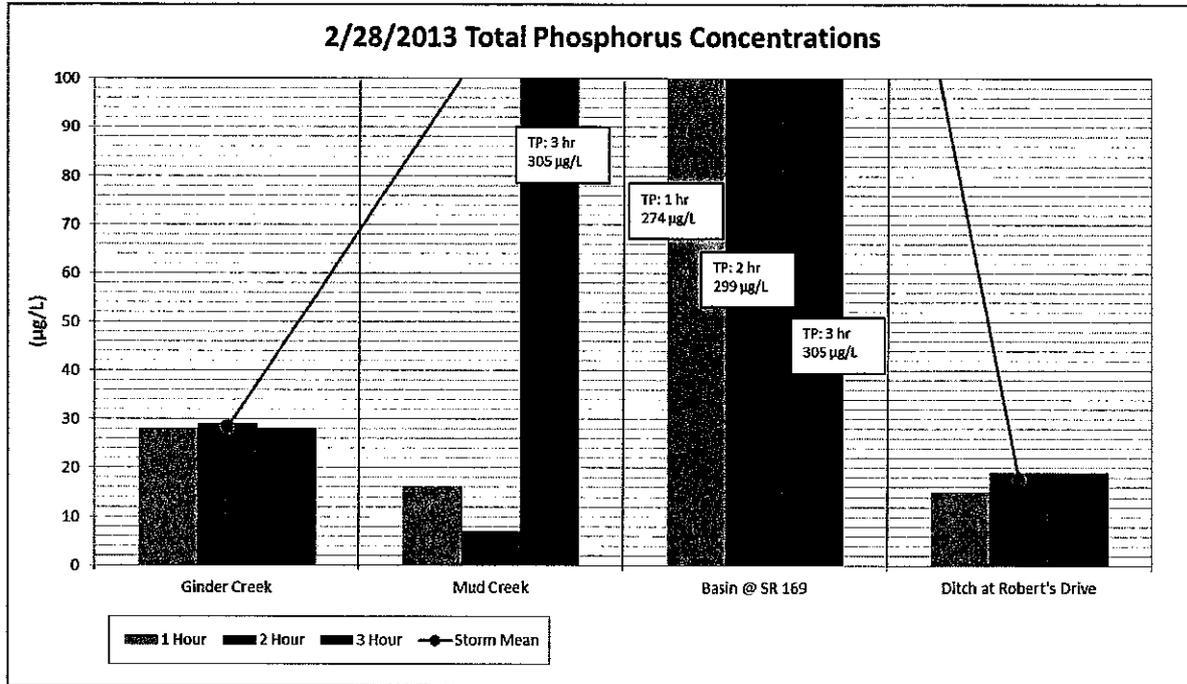
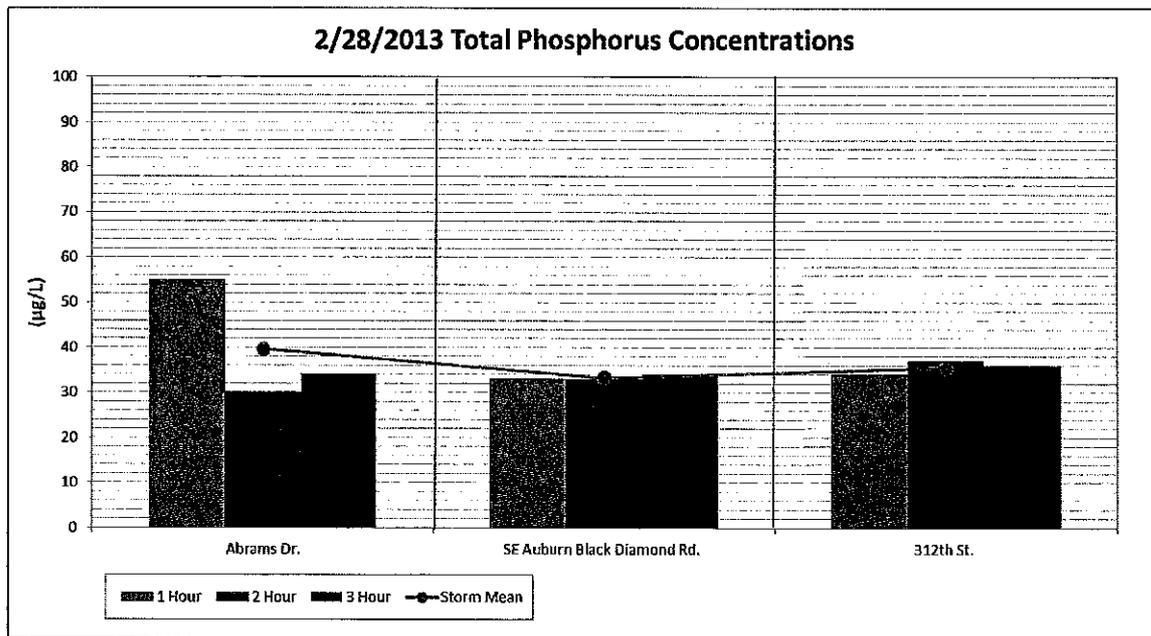
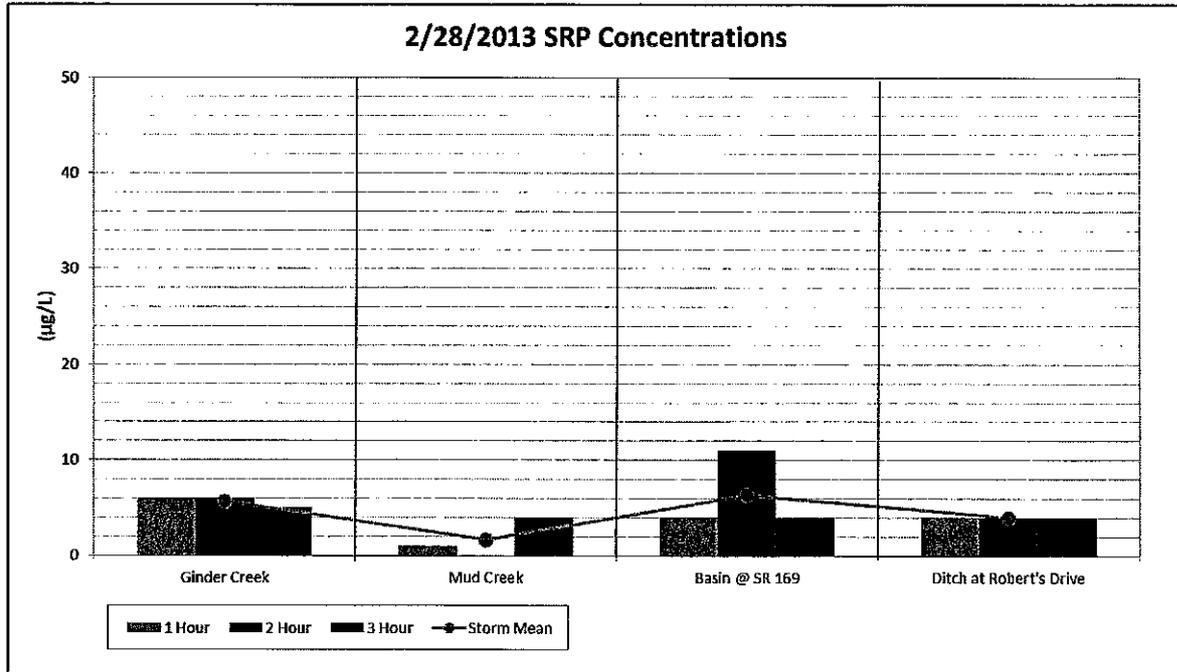
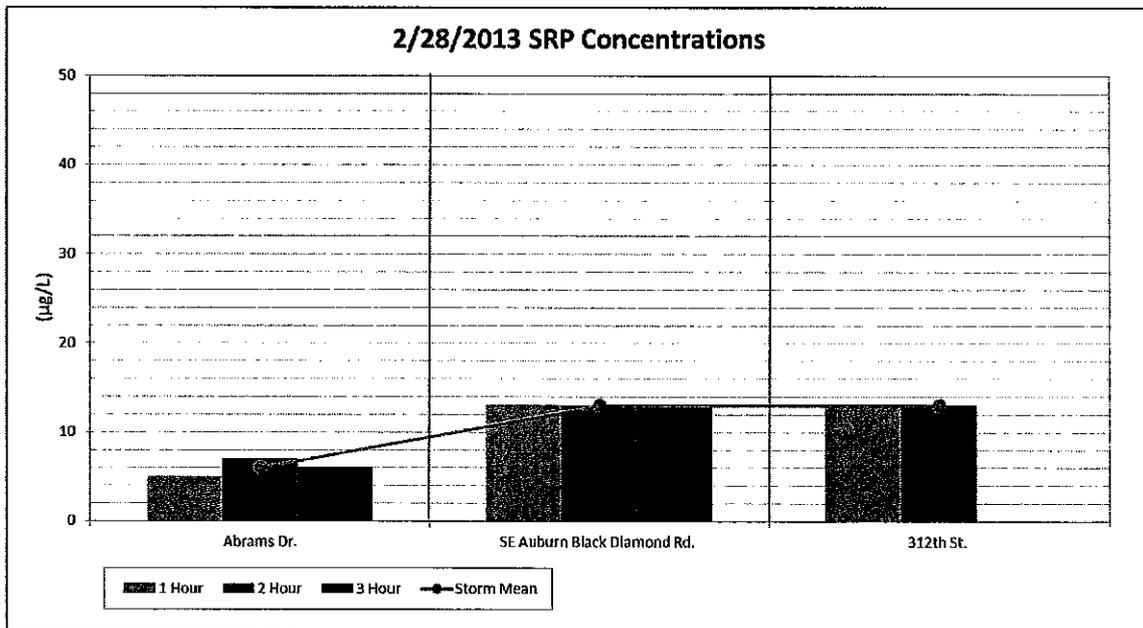
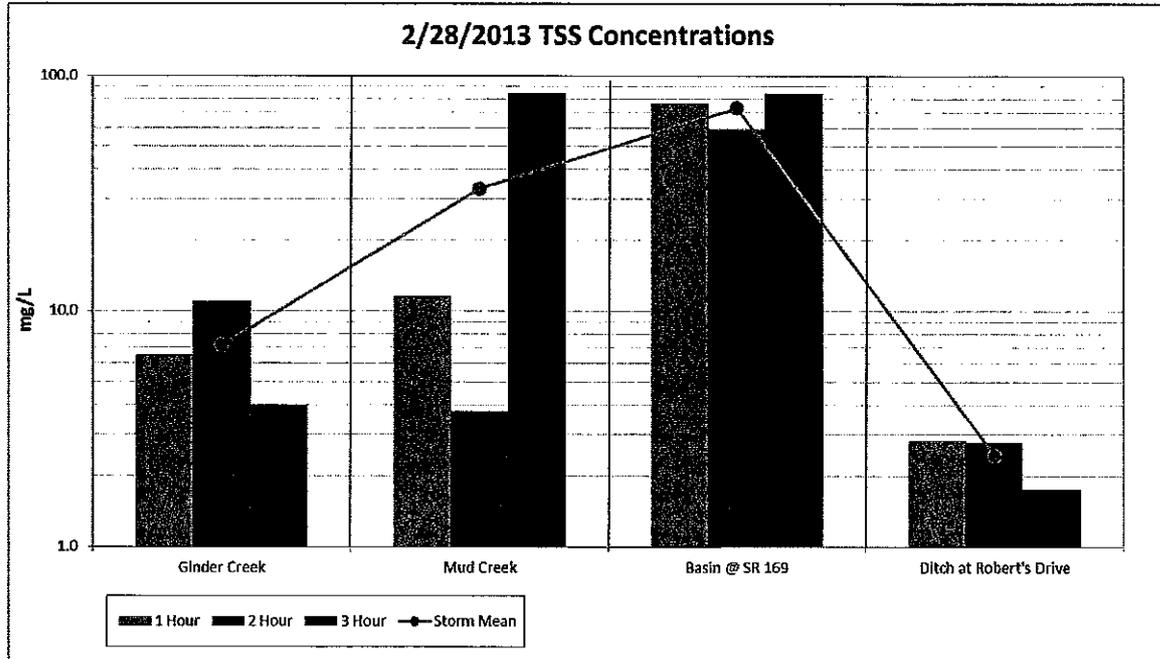
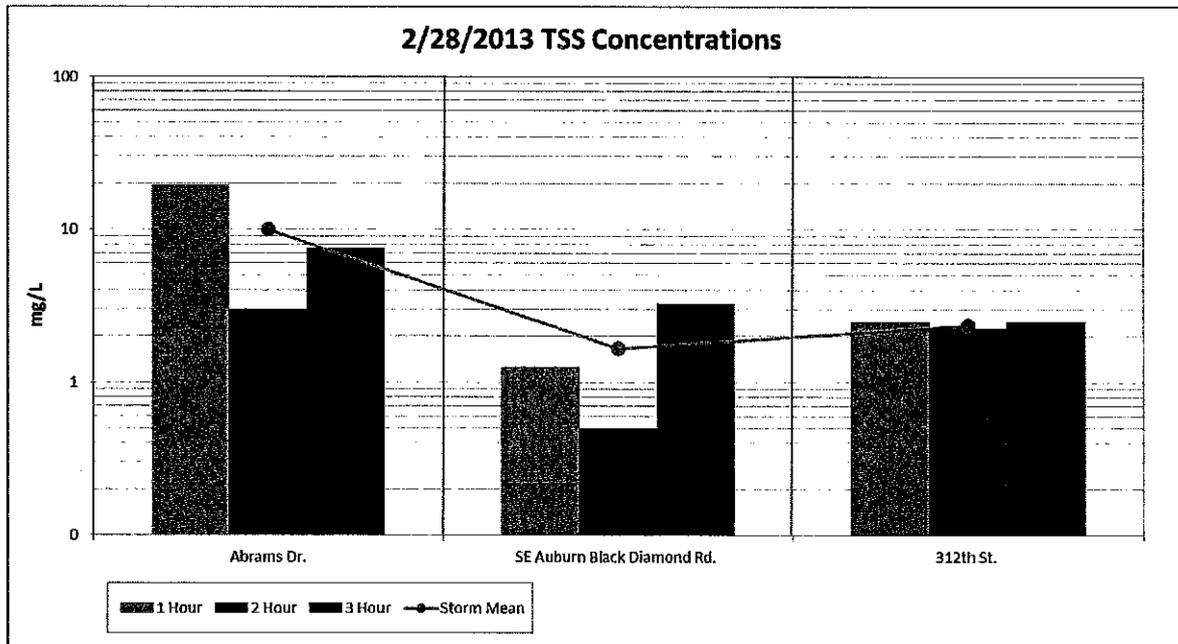
Figure 41. Total phosphorus concentrations for the Lake Sawyer drainage during the 2/28/2013 stormwater sampling event

Figure 42. Total phosphorus concentrations for the Rock Creek drainage during the 2/28/2013 stormwater sampling event

Figure 43. Soluble reactive phosphorus concentrations for the Lake Sawyer drainage during the 2/28/2013 stormwater sampling event

Figure 44. Soluble reactive phosphorus concentrations for the Rock Creek drainage during the 2/28/2013 sampling event

Figure 45. Total suspended solids concentrations in the Lake Sawyer drainage during the 2/28/2013 stormwater sampling event

Figure 46. Total suspended solids concentrations in the Rock Creek drainage during the 2/28/2013 stormwater sampling event

Water quality data from laboratory analysis for the February 28, 2013 storm event are presented in Appendix 1, Table A8 and field water quality measurements are reported in Table A9. A comparison of TP, SRP, and TSS results among sites are found below in Figures 41-46.

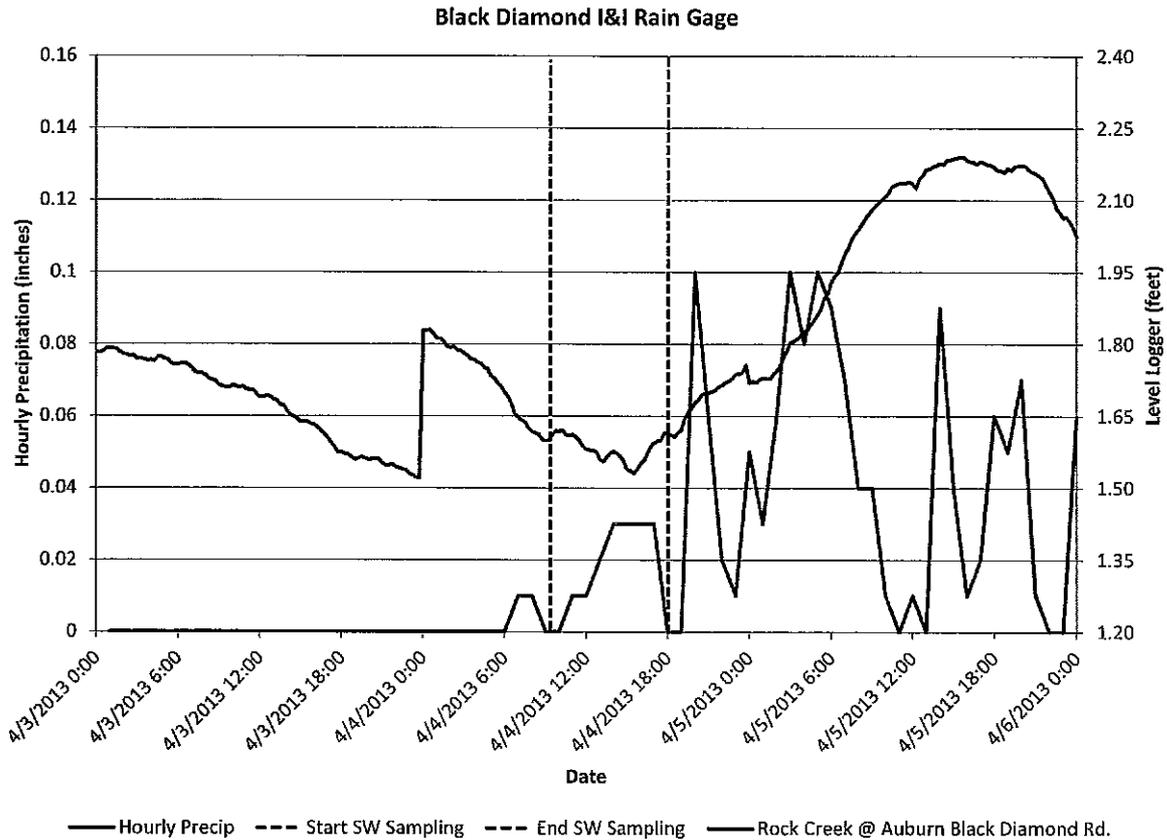
Figure 47. Precipitation at the Black Diamond I&I Rain Gage for the April 4, 2013 Sampling Event Compared to Rock Creek Water Level Recorded at SE Auburn Black Diamond Road.

Stormwater samples were collected from 9:45 to 17:55 on April 4, 2013. Figure 47 shows precipitation at the Black Diamond I&I rain gage (operated by King County) during the sampling event compared to water level recorded in Rock Creek at SE Auburn Black Diamond Road. Precipitation for April 4, 2013 (for the 24 hour period) totaled 0.18 inches and represented conditions at the end of the wet season.

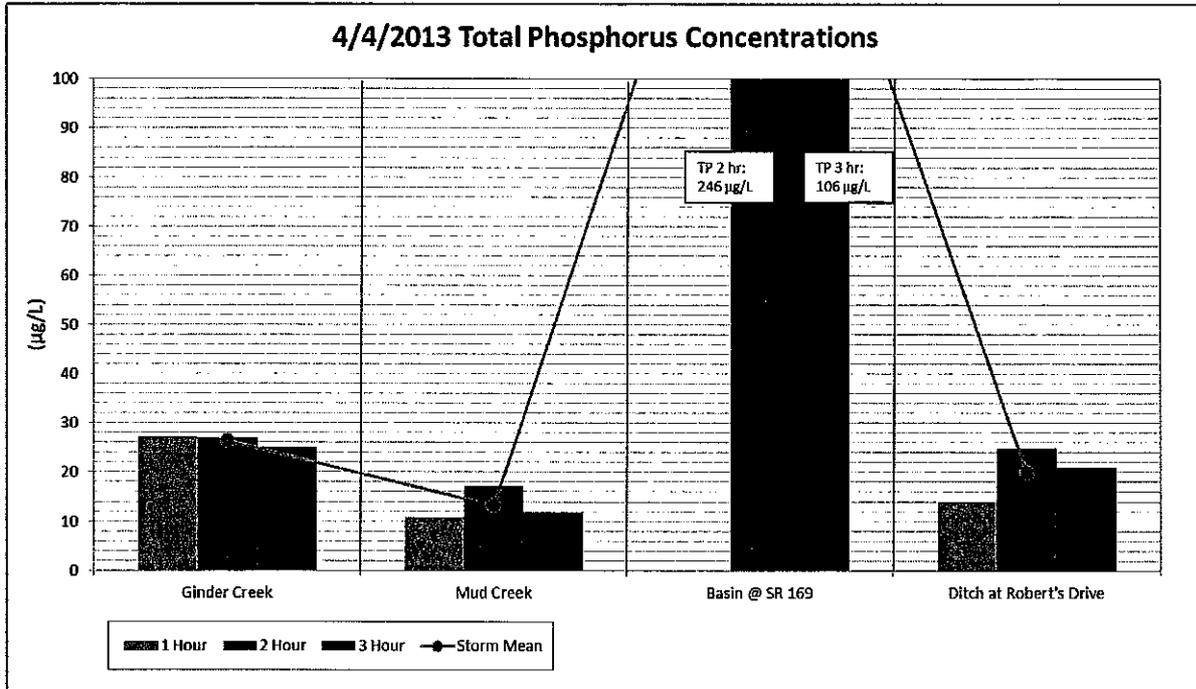
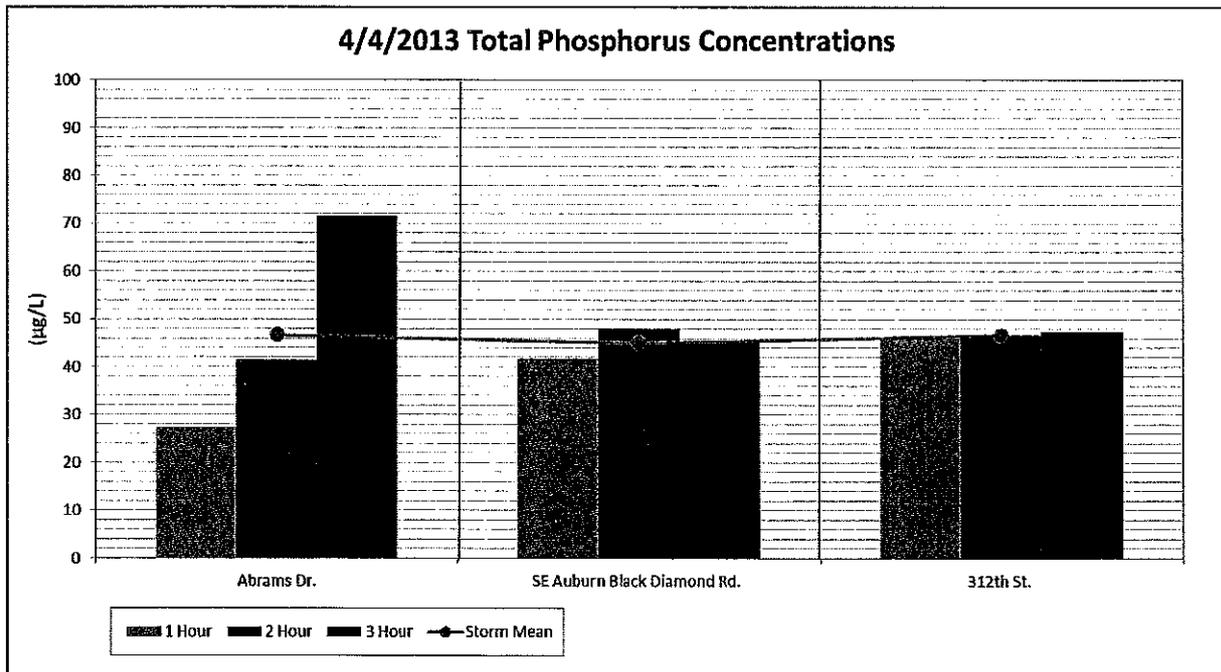
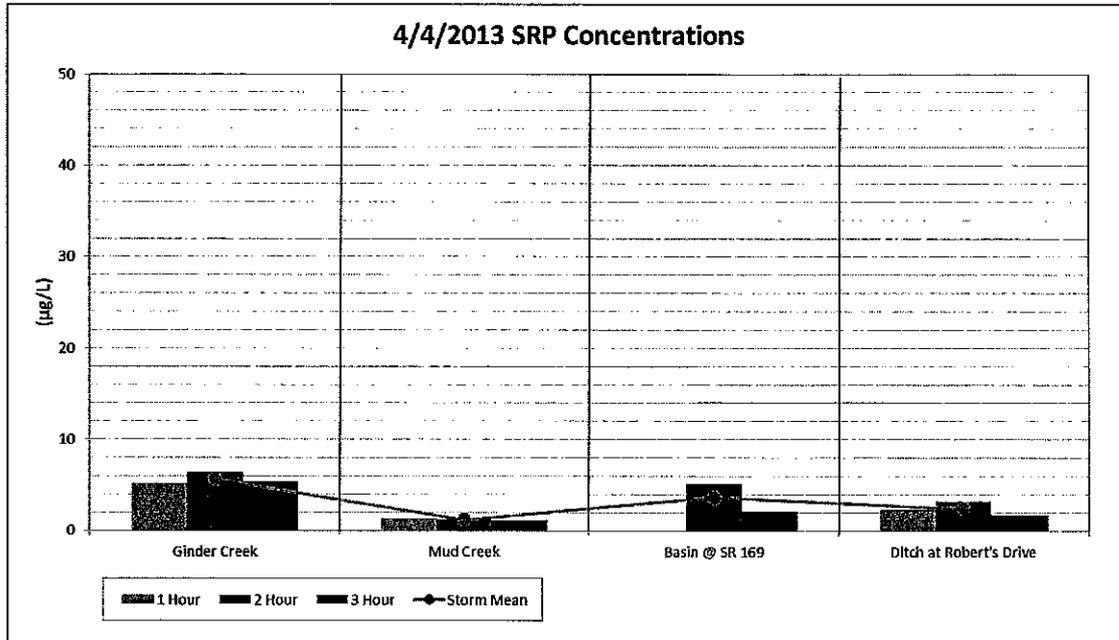
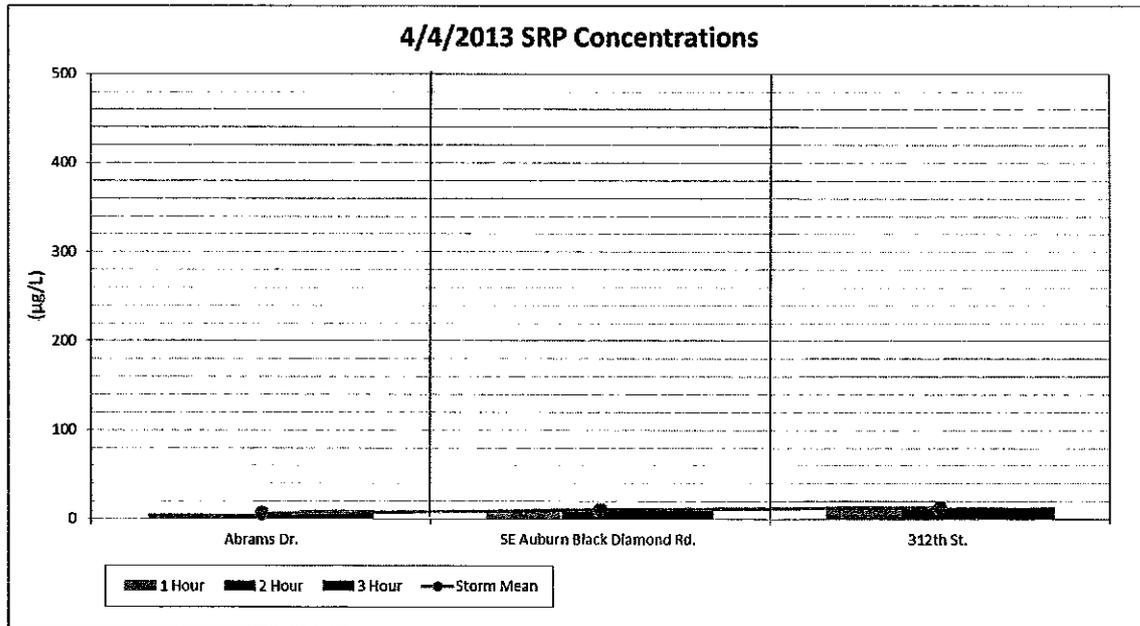
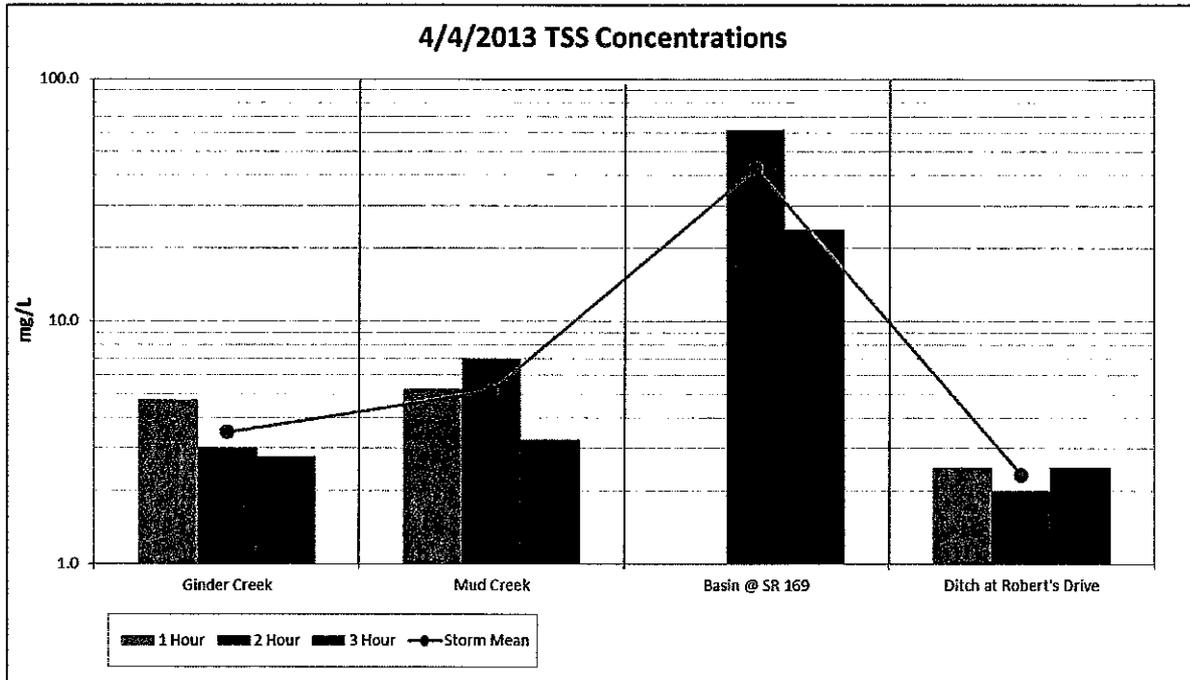
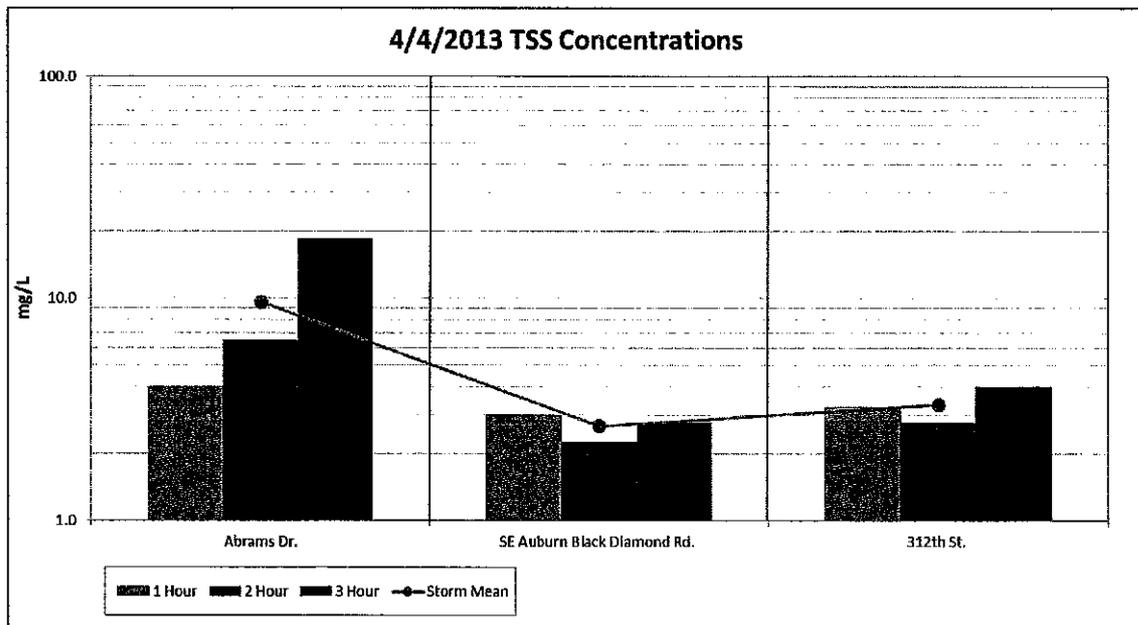
Figure 48. Total phosphorus concentrations for the Lake Sawyer drainage during the 4/4/2013 stormwater sampling event

Figure 49. Total phosphorus concentrations for the Rock Creek drainage during the 4/4/2013 stormwater sampling event

Figure 50. Soluble reactive phosphorus concentrations for the Lake Sawyer drainage during the 4/4/2013 stormwater sampling event

Figure 51. Soluble reactive phosphorus concentrations for the Rock Creek drainage during the 4/4/2013 sampling event

Figure 52. Total suspended solids concentrations in the Lake Sawyer drainage during the 4/4/2013 stormwater sampling event

Figure 53. Total suspended solids concentrations in the Rock Creek drainage during the 4/4/2013 stormwater sampling event

Water quality data from laboratory analysis for the April 4, 2013 storm event are presented in Appendix 1, Table A10. A comparison of TP, SRP, and TSS results among sites are found below in Figures 48-53.

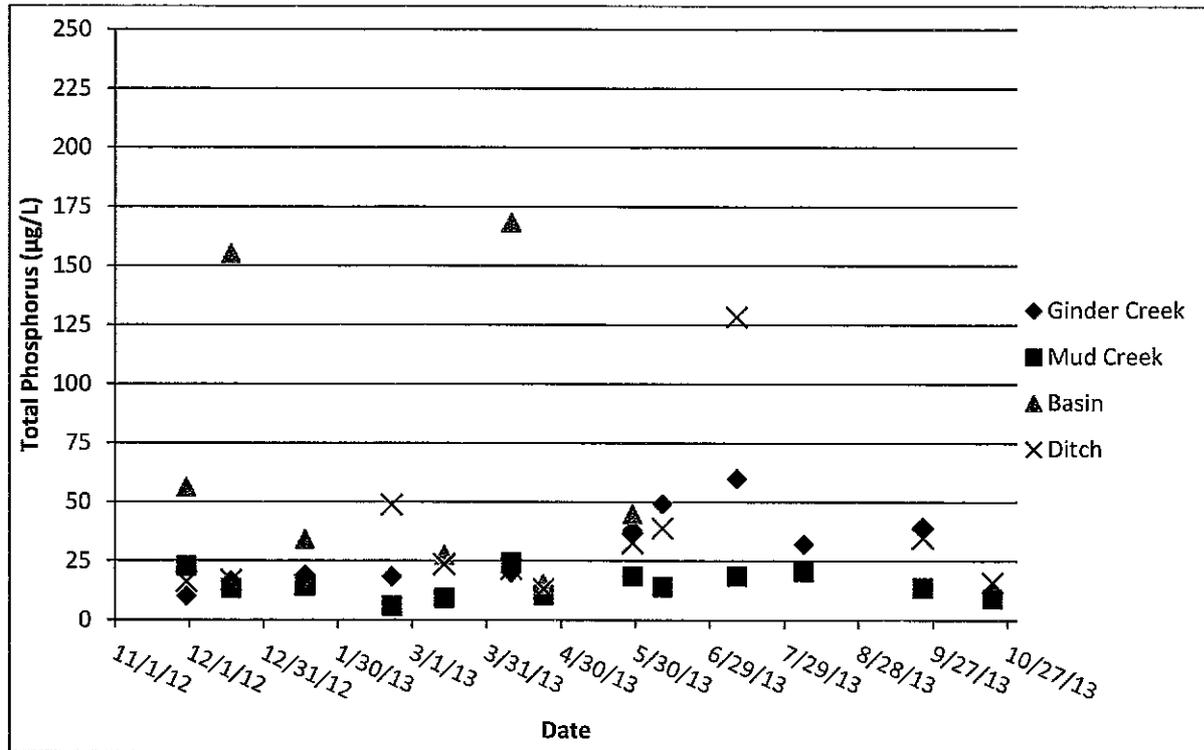
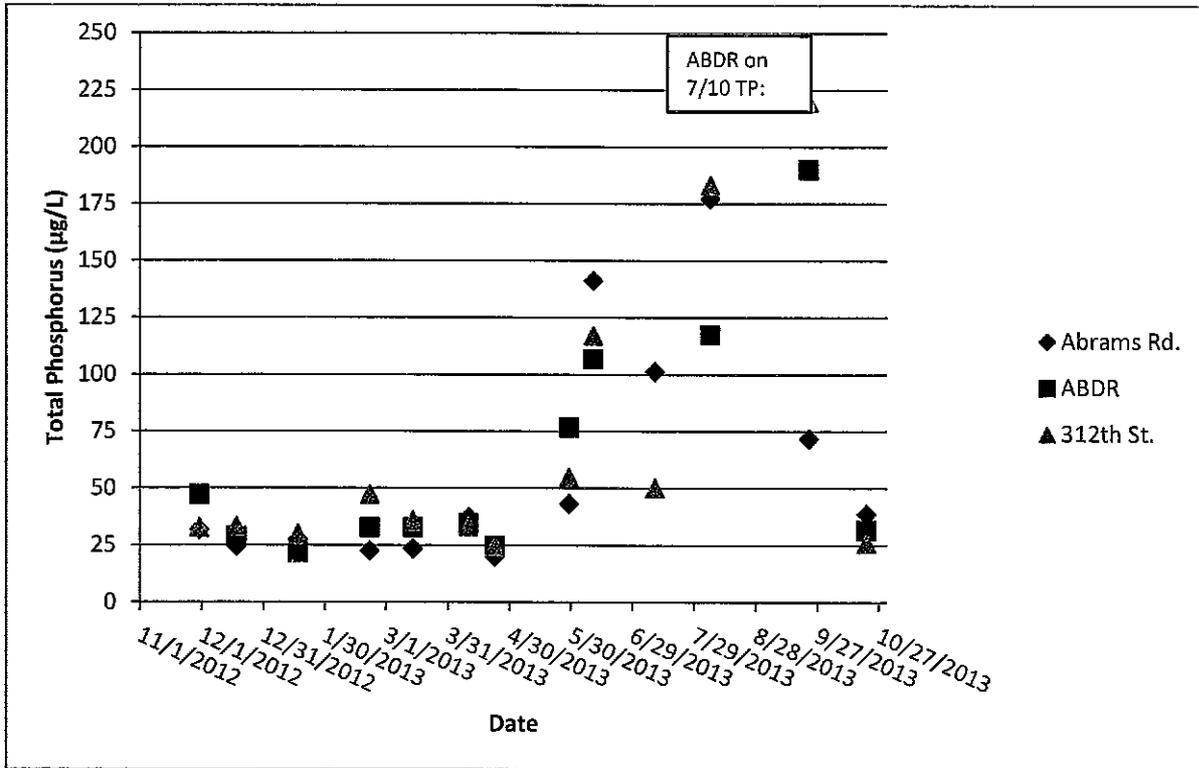
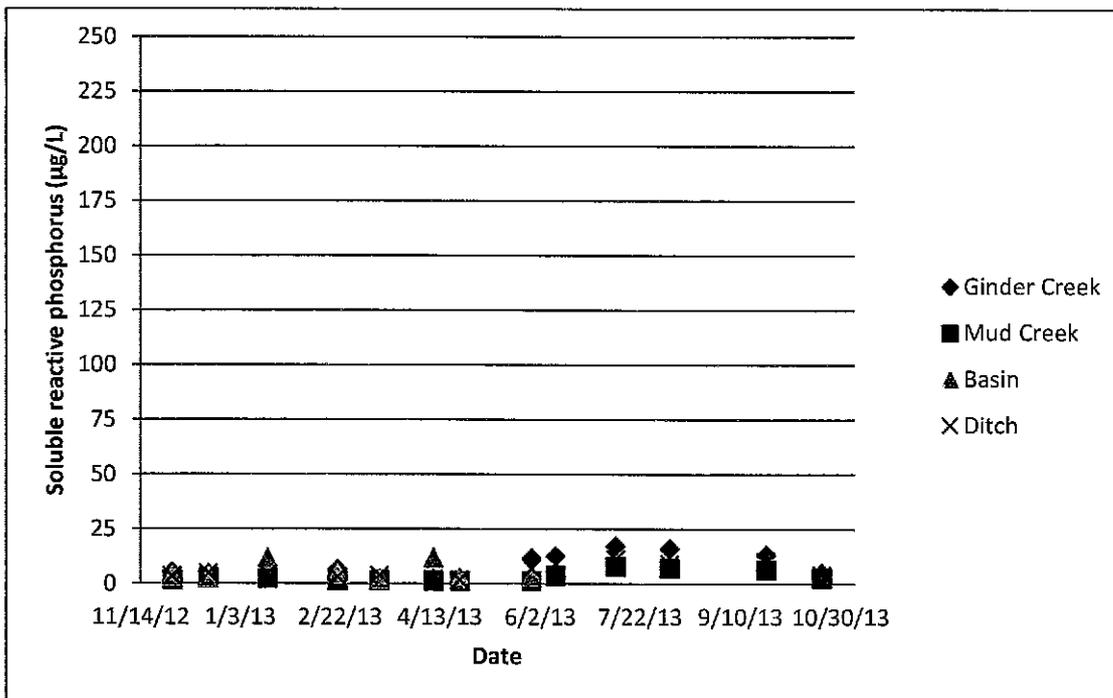
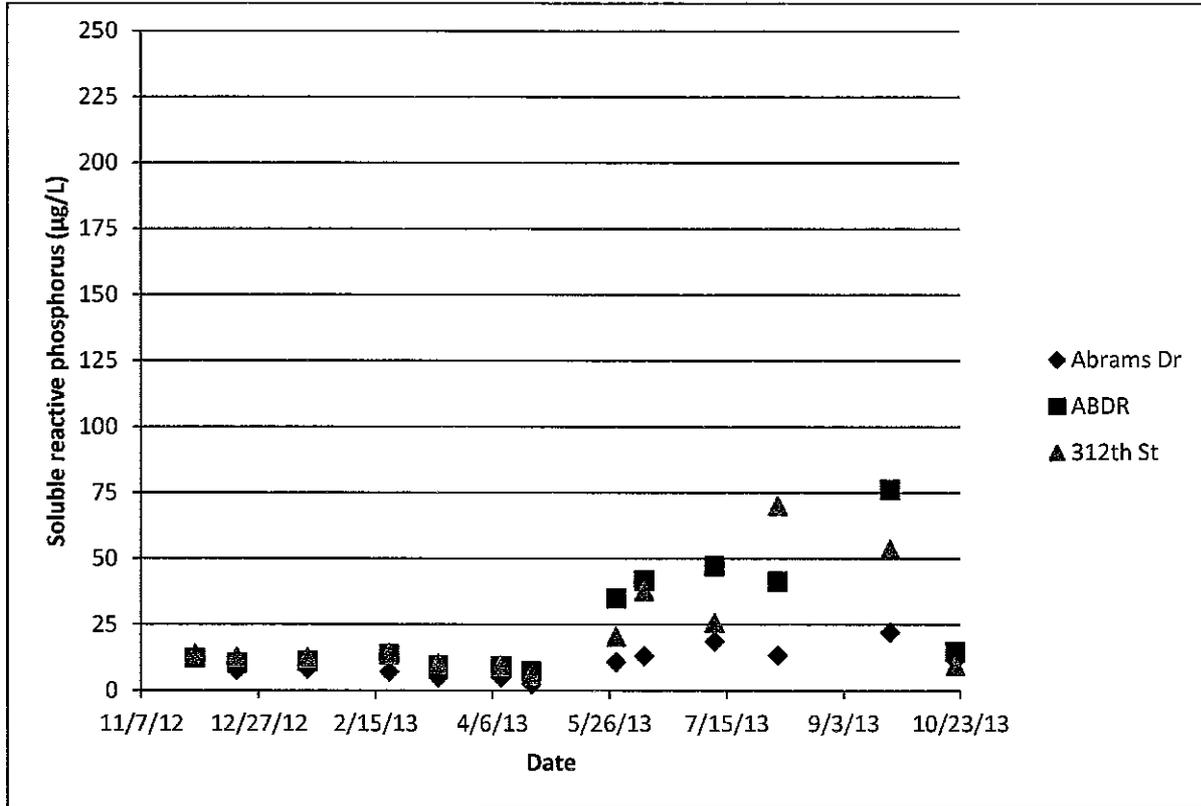
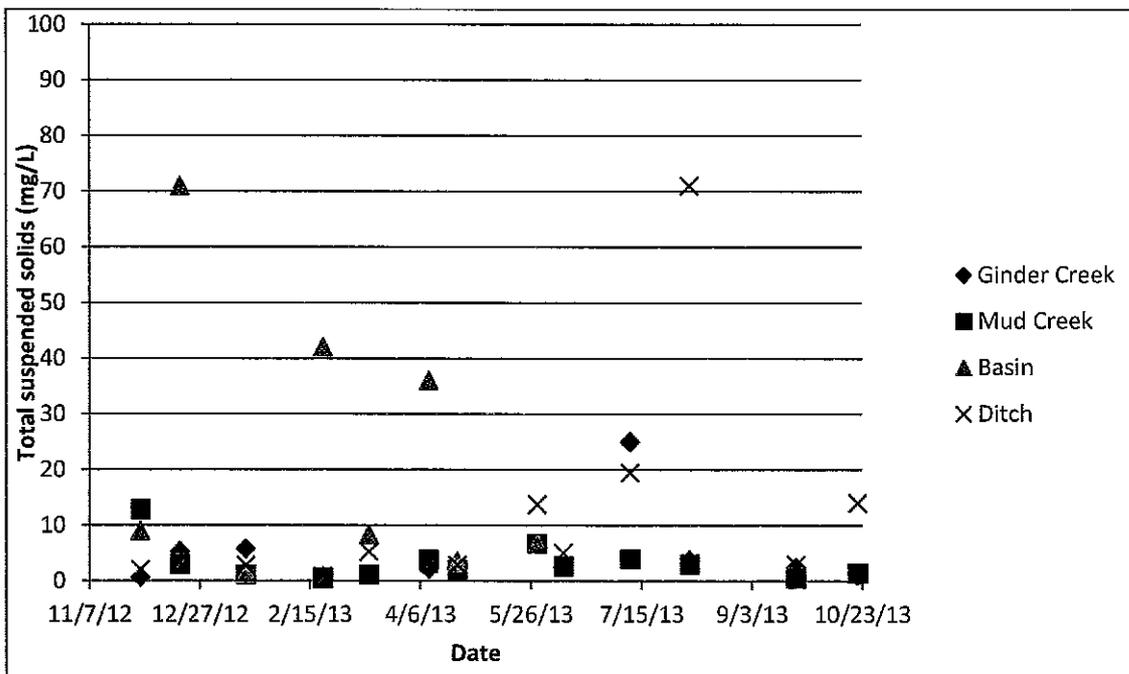
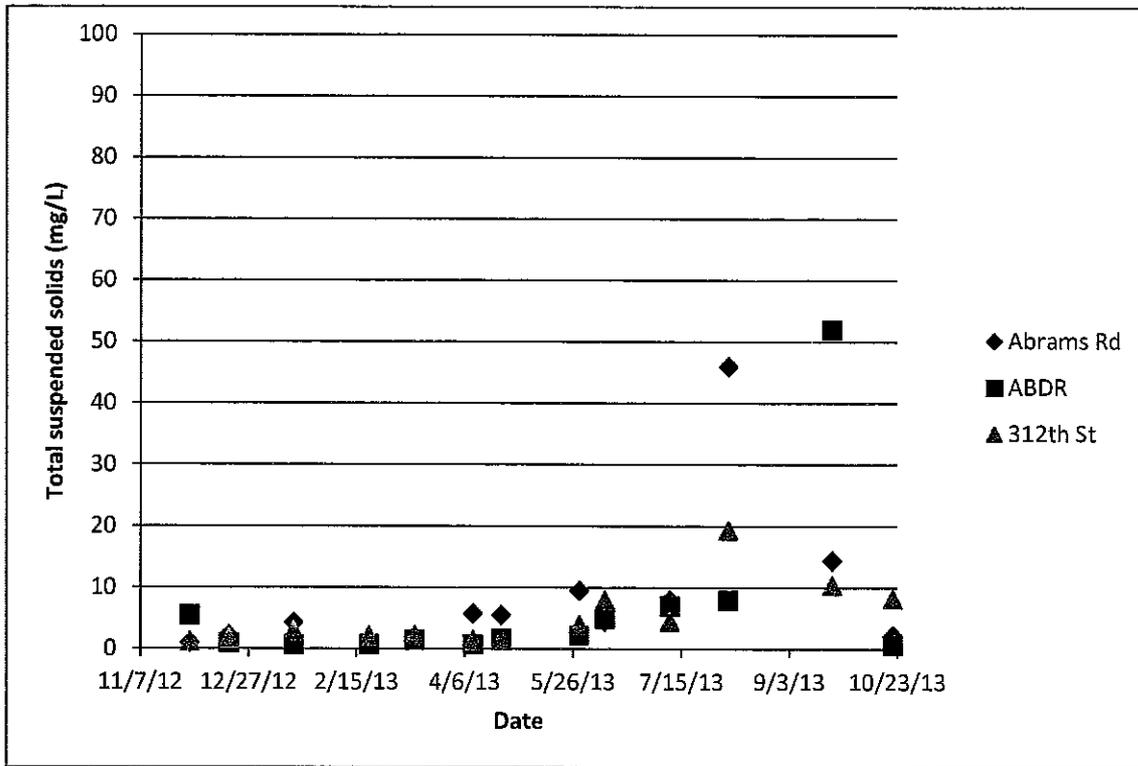
Figure 54. Total phosphorus ambient monitoring results for the Lake Sawyer drainage from November 2012- October 2013

Figure 55. Total phosphorus ambient monitoring results for the Rock Creek drainage from November 2012 through October 2013

Figure 56. Soluble reactive phosphorus monitoring results from the Lake Sawyer drainage from November 2012 through October 2013

Figure 57. Soluble reactive phosphorus concentrations for the Rock Creek drainage from November 2012 through October 2013

Figure 58. Total suspended solids concentrations for the Lake Sawyer drainage from November 2012 through October 2013

Figure 59. Total suspended solids concentrations for the Rock Creek drainage from November 2012 through October 2013

Water quality data from laboratory analysis, as well as field data are presented in Appendix 1, Tables A11- A36. A comparison of TP, SRP, and TSS results among sites during each month, with averages, are found below in Figures 54-59.
