THE VILLAGES AND LAWSON HILLS MPDs
2012-2013 PRE-CONSTRUCTION
STORMWATER MONITORING IN ROCK CREEK
TO ESTABLISH THE BASELINE PHOSPHORUS LOAD

BLACK DIAMOND, WA

NOVEMBER 2013

(REVISED JANUARY 2014)

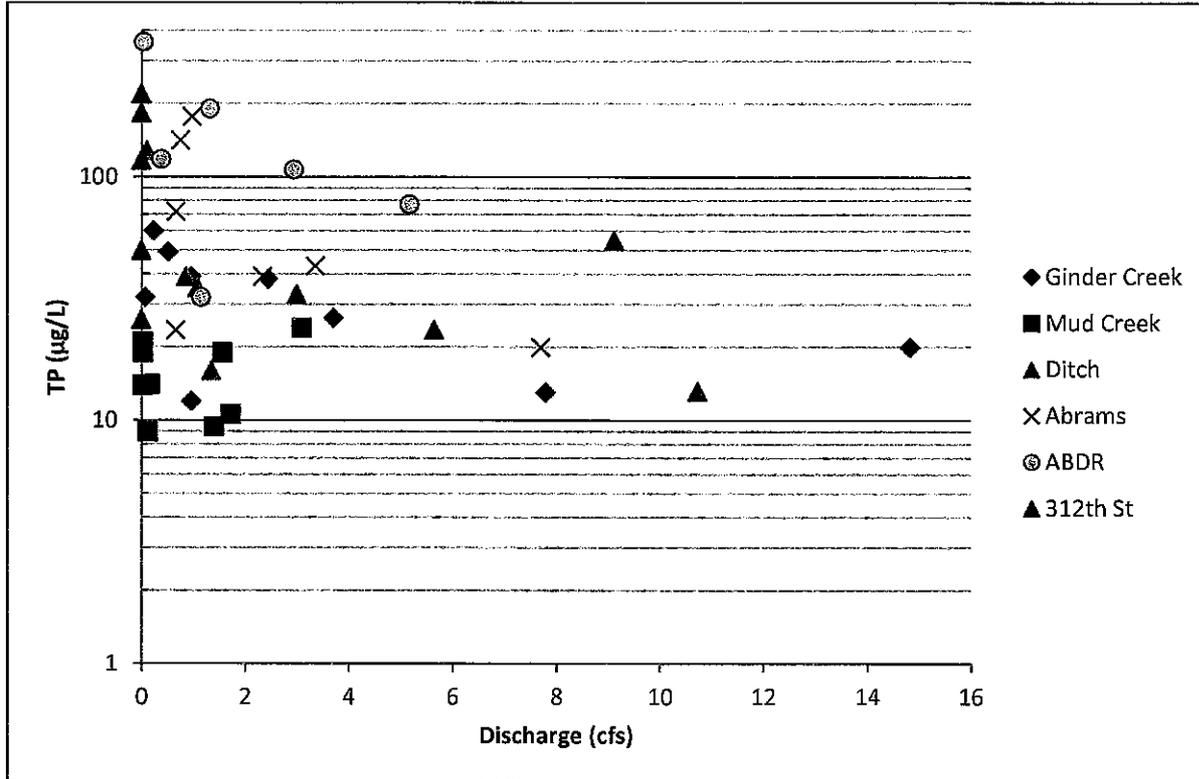
Figure 60. TP concentrations vs discharge at each site from April-October 2013

The following figures show discharge for each site during the time of sampling events versus the concentration of TP (Figure 60) and TSS (Figure 61).

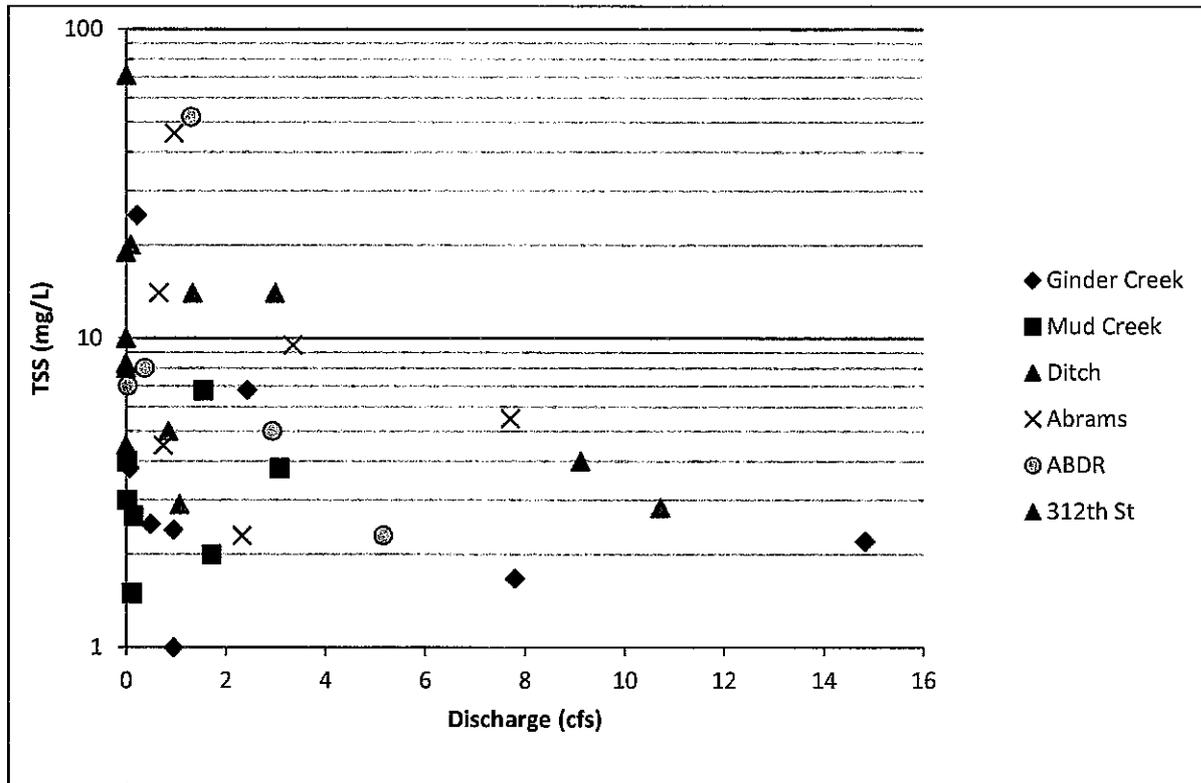
Figure 61. TSS concentrations vs discharge at each site from April-October 2013

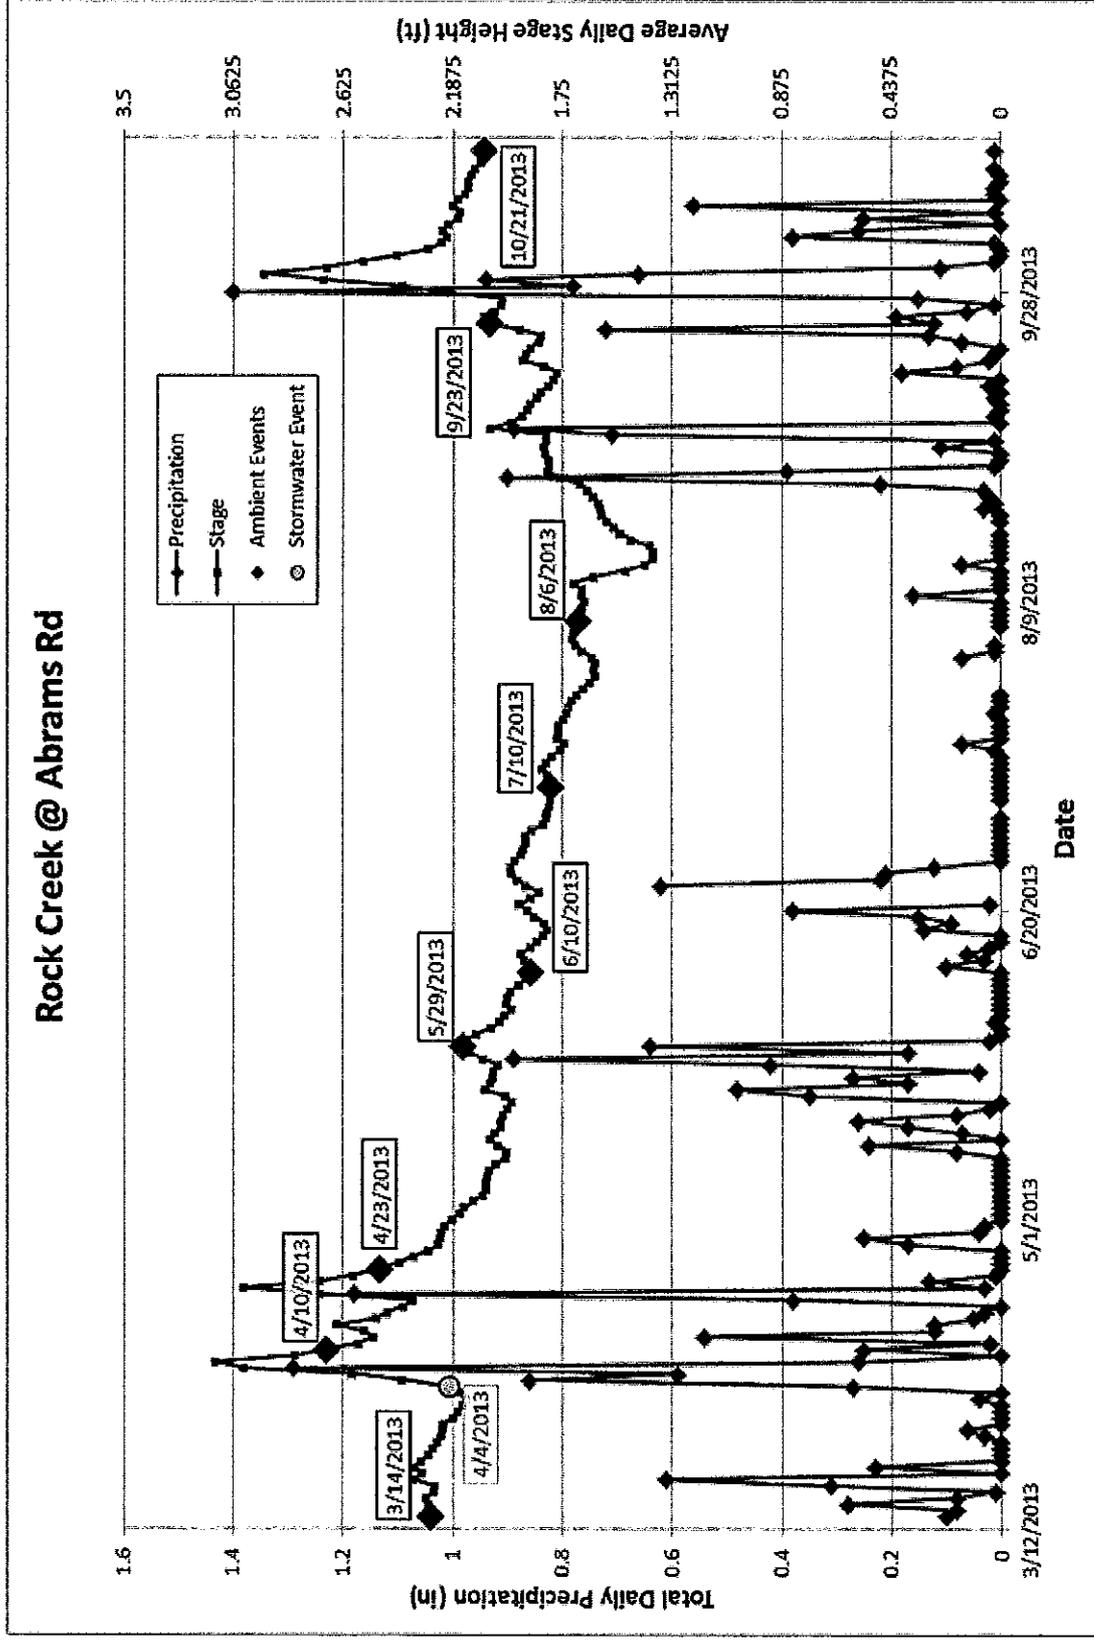
Figure 62. Precipitation versus Stage Height from March 2013-October 2013 at the Abrams Avenue site

The following 3 figures (62-64) show total daily precipitation amounts from April-October 2013 and the corresponding water level rise at each site as measured by the stage height recorders. Sampling events are also noted along the stage height line graph.

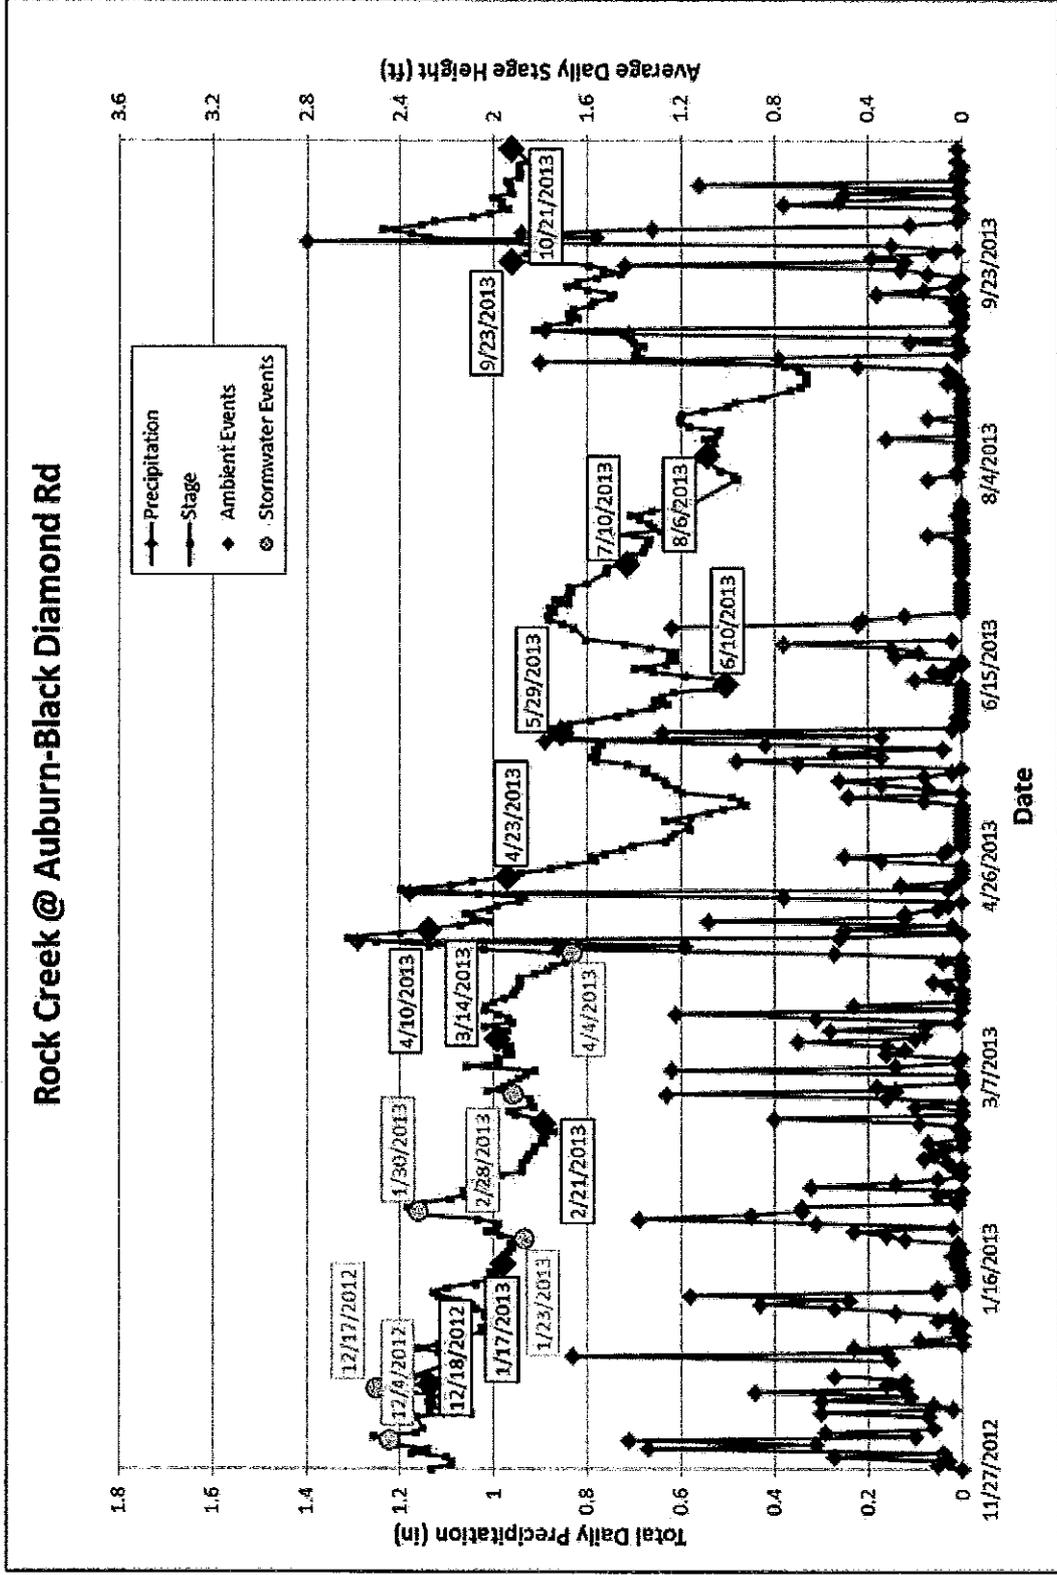
Figure 63. Precipitation versus Stage Height from November 2012-October 2013 at the Auburn Black Diamond (ABDR) site

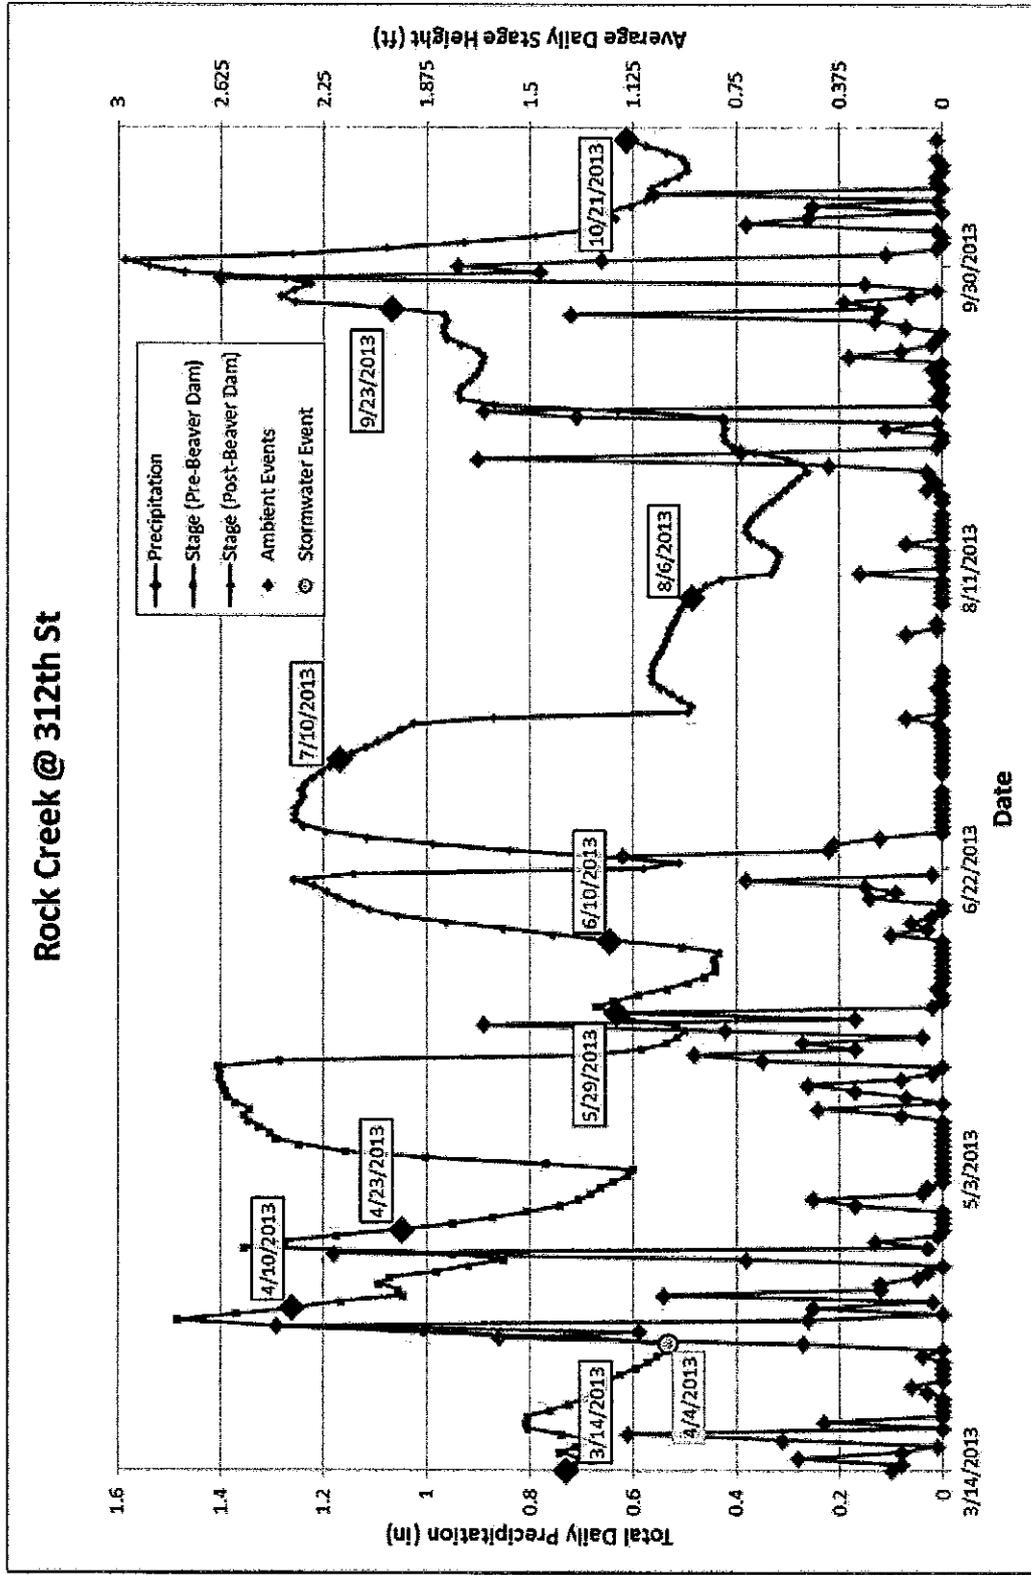
Figure 64. Precipitation versus Stage Height from March 2013-October 2013 from the 312th Street site

Monitoring events characterized at the 312th Street site were reported for the length of the stage height record beginning March 2013 through October 2013. Additional storm event and baseline monitoring was completed extending from November 2012. The stage height recorded water levels above this site before and after appearance of beavers and their work. The water levels above the 312th Street sites were designated as before beaver dam (red line) and following establishment of a beaver dam (green line) in Figure 64.
